## Some observations and considerations on the damage to structures and coasts induced by the tsunami of the 2004 Sumatra earthquake

Ömer AYDAN<sup>\*1</sup>, Masanori HAMADA<sup>\*2</sup> and Tomoji SUZUKI<sup>\*3</sup>

The Sumatra earthquake of December 26, 2004 with a moment magnitude of 9.0 induced the most disastrous tsunami known in the history of mankind. The authors as the members of the reconnaissance team dispatched by Japan Society of Civil Engineers to Aceh Province of Indonesia visited the tsunami affected area and had the chance to observe the damage induced by the tsunami on various structures and the western and north-east coasts of Sumatra Island through land and aerial surveys. The tsunami wave height was 20m on the western coast and 10m in Banda Aceh City, which is the capital of the Aceh province. More than 220000 people were killed in countries neighboring Indian Ocean. The number of people killed in Aceh province was 160000 alone and some of towns and villages on the western coast were completely wiped away from the surface of the earth. The structures surveyed by the authors involve harbors, industrial facilities, airports, bridges, roadways, natural or cut

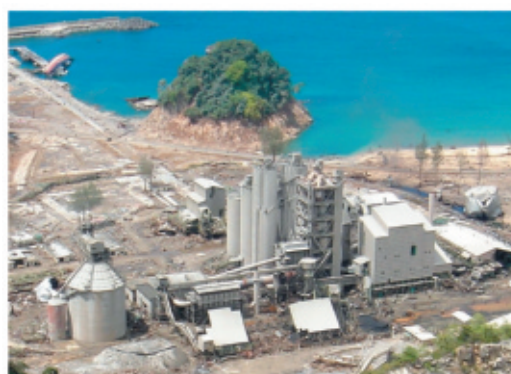
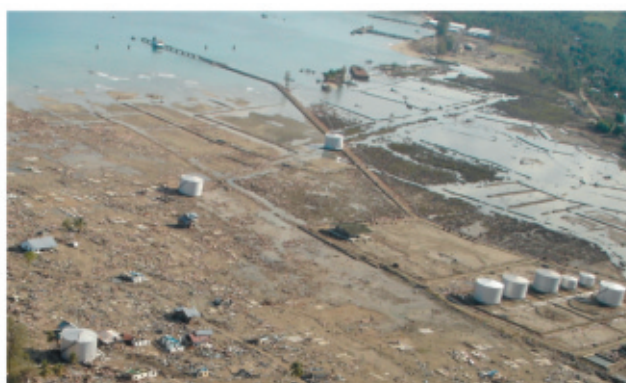
Aceh province is one of the major oil and natural gas producing regions in Indonesia. These facilities are on the east coast of province. None of these facilities were damaged either by ground shaking or induced tsunami. However, the cement plant at Lhonga was heavily damaged by tsunami waves. A French company originally built the plant and an Indonesian company now operates it. The steel structure sections, kiln and fuel storage tanks were heavily damaged by tsunami while RC silos remained intact (Figure 10(a)). It seems that tsunami waves reached a height of 15–20m in some sections and the steel beams and columns were either bended or buckled by the impact of tsunami waves and dragged objects. There were two cylindrical fuel tanks in the plant. One of them was completely destroyed while the other one was buckled and it was offset from its original location. Storage tanks from an oil tank farm in the eastern part of Banda Aceh city were displaced by the tsunami waves for a considerable distance from their original position as seen in Figure 10(b). The tanks were not fixed to the ground and some damage to piping did occur. An oil tank along the seashore in Meulaboh was hit by tsunami waves and that side of the tank was buckled. Furthermore, the settlement of the base of the tank occurred probably due to the liquefaction of foundation ground.

(a) Damaged cement factory

(b) Damaged oil tank farm and displaced tanks

**Figure 10** Damage by the tsunami on industrial facilities

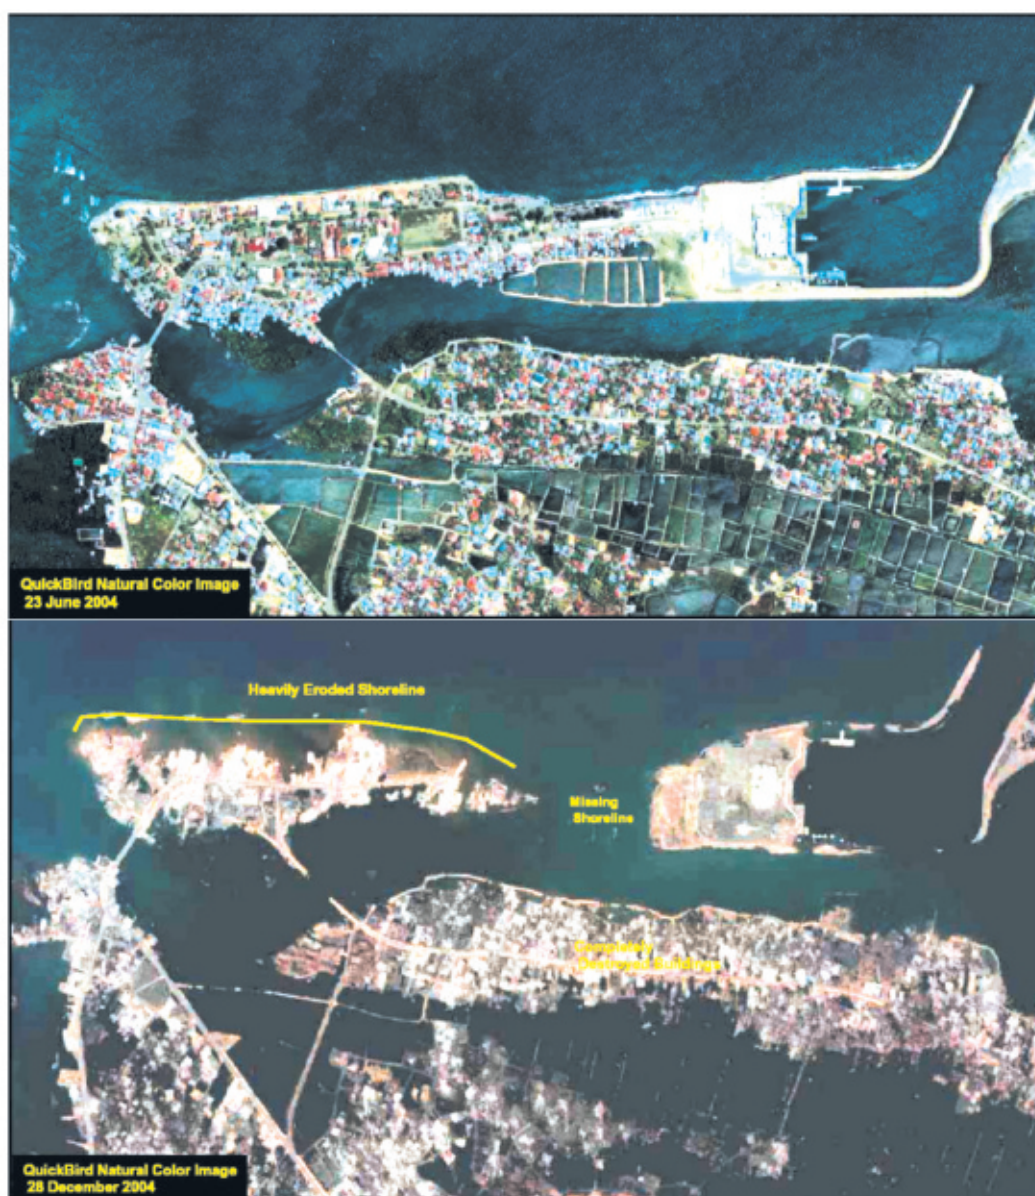
Tsunami induced heavy damage to ports and coastal facilities along the west and north coast of Sumatra Island. Figure 11 shows satellite views of Banda Aceh harbor before and after the earthquake. As noticed from the comparison of two satellite views, a huge area was damaged by the tsunami as a result of settlement and erosion due to probably ground liquefaction induced by ground shaking as well as due to the tsunami. The ground consists of sandy soil in this area. It is also of great interest that some parts of the dykes of the harbor disappeared. Besides the effects of liquefaction, the flow direction of tsunami waves might have some damaging effects on the missing section of the dykes.

Figure 11 Satellite views of Banda Aceh port before and after the earthquake

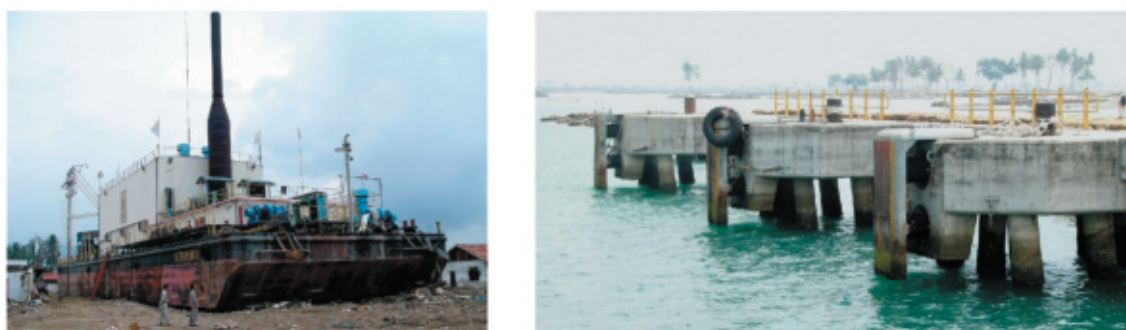
The RC building of the port facility collapsed at the ground floor. However, the main cause of collapse was ground shaking rather than the tsunami waves. Large stone blocks were thrown by the tsunami waves over the wharf of the port. Although the wharf of a barge with a power generator was not damaged by the tsunami as seen in Figure 12, the barge was displaced from the wharf to a distance of 3km inland.

Figure 12 Displaced barge with a power generator and its wharf (JSCE, 2005)

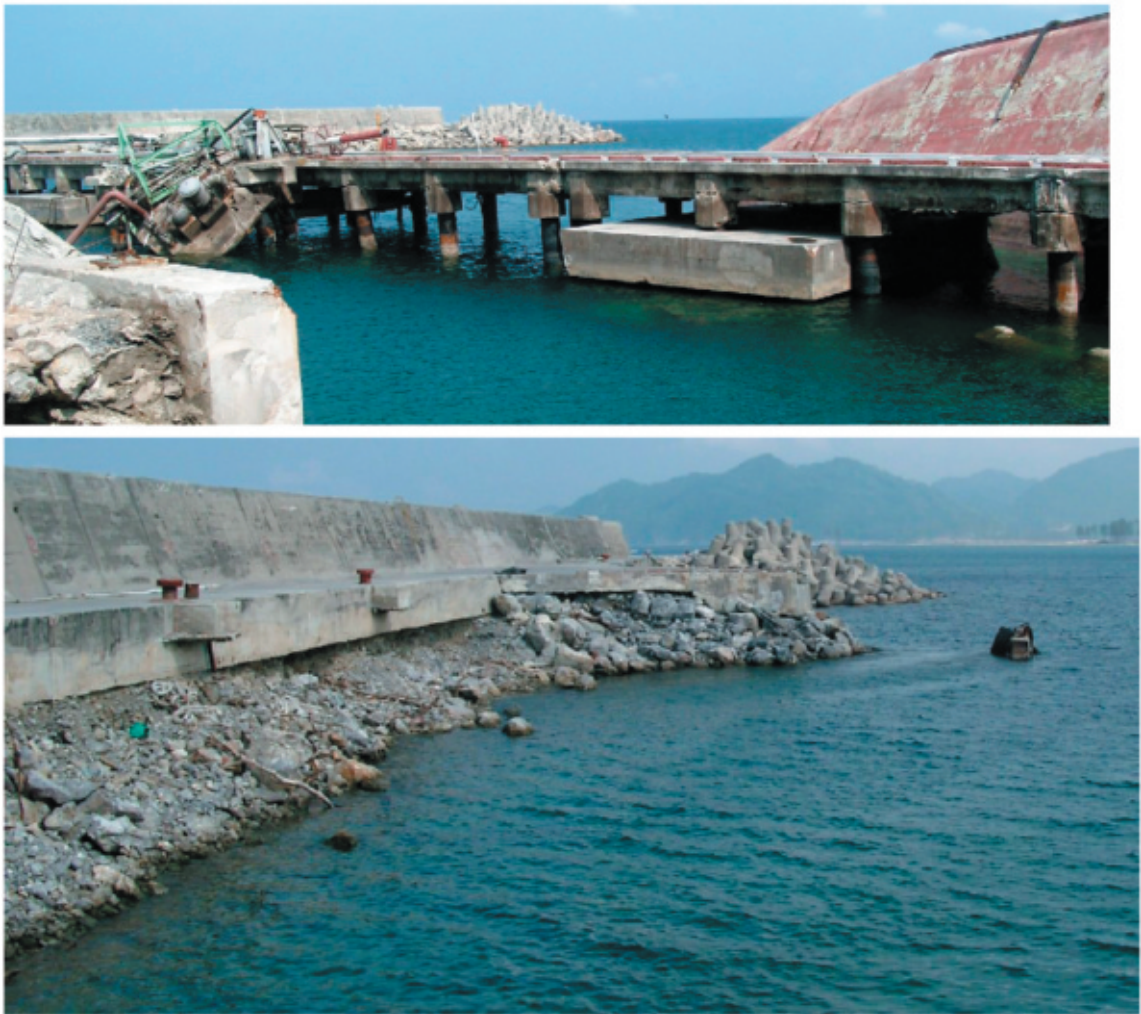
The port facility for the cement factory was also damaged by the tsunami. The piles of the wharf of the port were fractured by the impact forces of the capsized ship moored to the wharf as seen in Figure 13(a). Furthermore, the tetrapods of the wave-break were displaced for a considerable distance due to whirling of the tsunami waves (Figure 13(b)).

Figure 13 Damaged wharf and displaced tetrapods of wave-break at Lhonga port

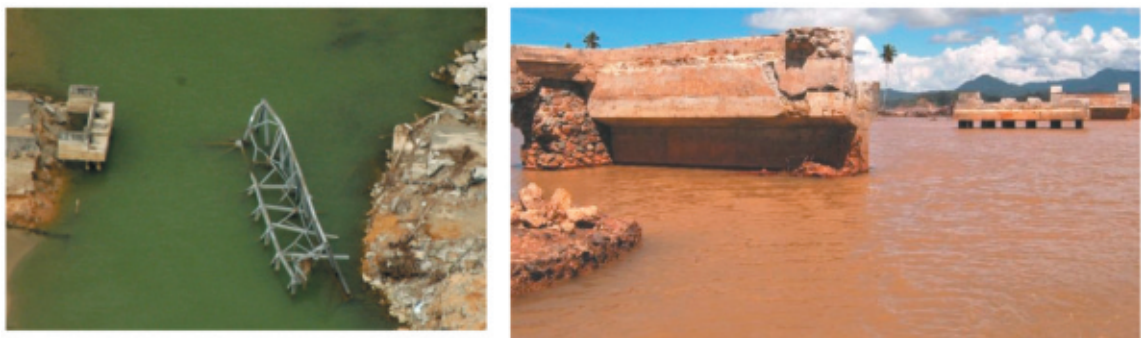
(a) Collapsed truss bridge (b) Collapsed concrete bridge

Figure 14 Some examples of collapsed truss and concrete bridges

Bridges are either of truss or reinforced concrete type. 21 truss type steel bridges were mainly uprooted from their bearings and 47 concrete bridges were collapsed or heavily damaged. The causes of the damage were the impact, drag and uplift forces of the tsunami as well as the impact of dragged objects by the tsunami waves. Figure 14 shows some examples of bridge failures. The following statements can be made on the damage of bridges:

- \* When bridges have no shear keys, the girders are easily displaced due to horizontal forces.
- \* When the bridges are sufficiently elevated for the unobstructed passage of tsunami and dragged materials, they are not damaged
- \* When there are some obstructions such as small hills next to the bridges against tsunami waves, there is almost no damage or very limited damage to bridges

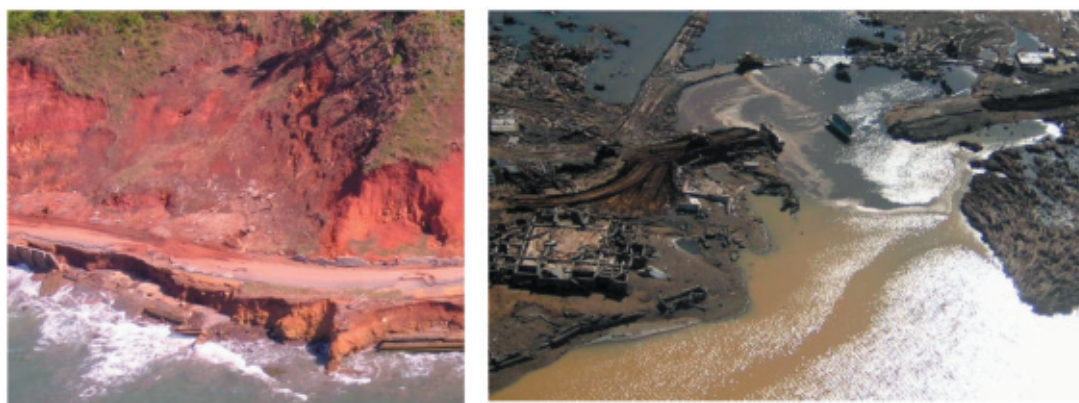
**Figure 15** Roadway damage due to erosion and failures of embankments

Damage to roadways was mainly due to the erosion resulting from tsunami waves, ground liquefaction or embankment failure (Figure 15). The damage was quite extensive in lowland area, nearby rivers and seashores next to steep slopes.

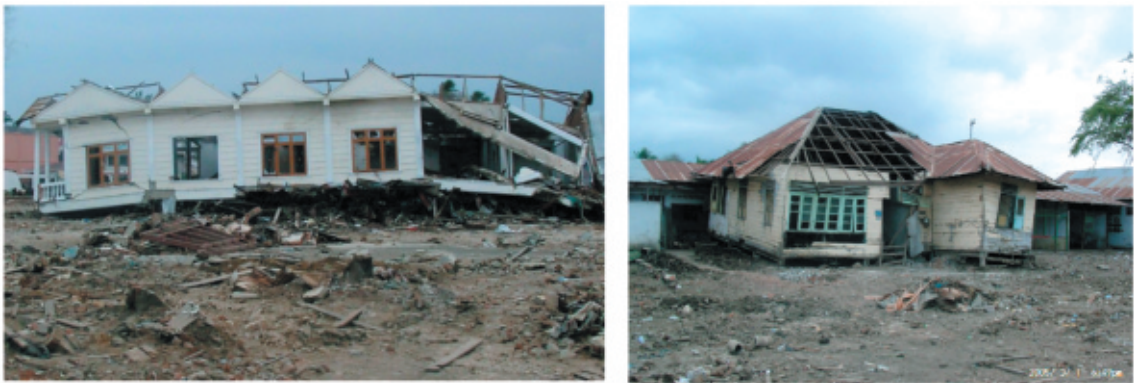
Wooden houses are generally single story or two story buildings. These buildings were almost non-damaged in the regions, which were not affected by the tsunami. Therefore the main cause of the damage was tsunami. The tsunami may impose at least four types of loading, namely, impact force, drag force, hydrostatic water loading and buoyancy (uplift) force on wooden buildings. While impact and drag forces directly related to the velocity of tsunami, the hydrostatic and buoyancy forces depend upon the tsunami height and relative density differences between the building material and tsunami waves. Figure 16 shows some examples of damage to wooden houses.

Figure 16 Damage to wooden houses

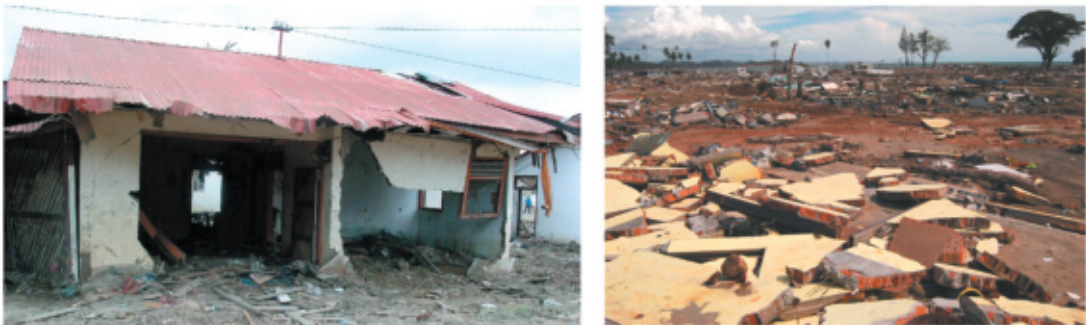
Figure 17 Damage to masonry (brick) buildings

tsunami waves could be drag forces and hydrostatic water loads. When the masonry (brick) houses are still standing, their walls were punched out. Figure 17 shows some example of damage to masonry (brick) houses.

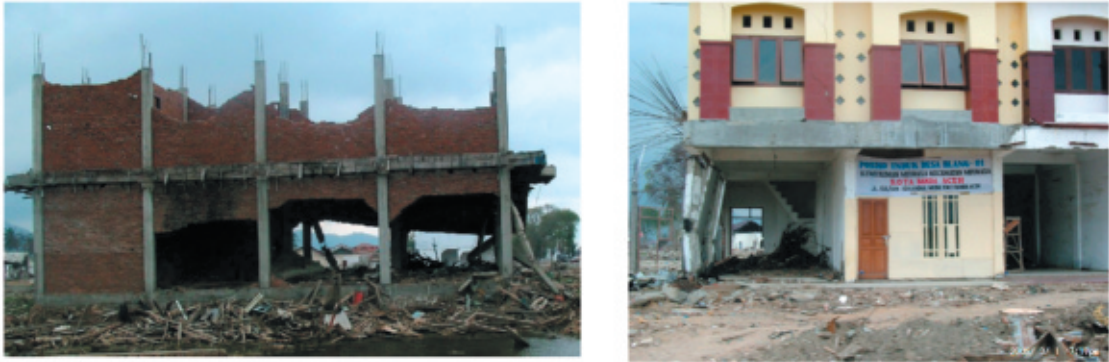
tsunami-affected areas have stories ranging between 2 and 3. Some of columns were broken and in-fill walls were punched out by the impact forces of tsunami waves and tsunami-dragged objects (Figure 18). Nevertheless, they survived against the ground shaking and also the forces resulting from tsunami waves. The columns were generally ruptured or fractured at their mid-height, which implies that they were subjected to high bending forces. Furthermore, the broken columns and punched-out walls were facing the flow direction of the in-coming tsunami waves.

Figure 18 Damage to RC buildings in tsunami-affected area

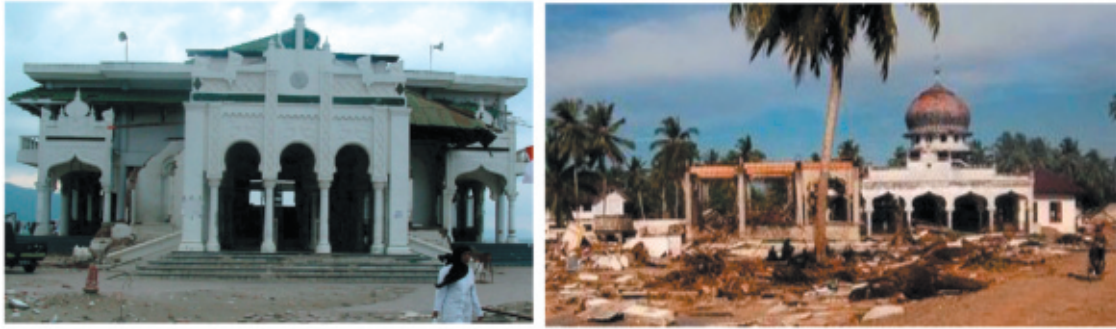
**Figure 19** Damage to mosques

structures without infill-walls. Mosques survived against the ground shaking and tsunami waves even in the severely hit areas (Figure 19). The possible reason for such a good performance against tsunami may be associated with its columnar structure without in-fill walls. The only mosque damaged in this earthquake is in Ulee Lheue district and the central RC column of the wall facing the sea was fractured by bending at mid-height. Many mosques built as masjid having no minarets. The grand mosques in Banda Aceh and Meulaboh have only minarets. Their minarets were lightly damaged, as they are slender structures.
