# The Characteristics of M8.7 Nias Earthquake of March 28, 2005 and Induced Tsunami and Structural Damages

Ömer AYDAN<sup>\*1</sup>, Shigeru MIWA<sup>\*2</sup>, Hiroyuki KODAMA<sup>\*2</sup> and Tomoji SUZUKI<sup>\*3</sup>

## Abstract

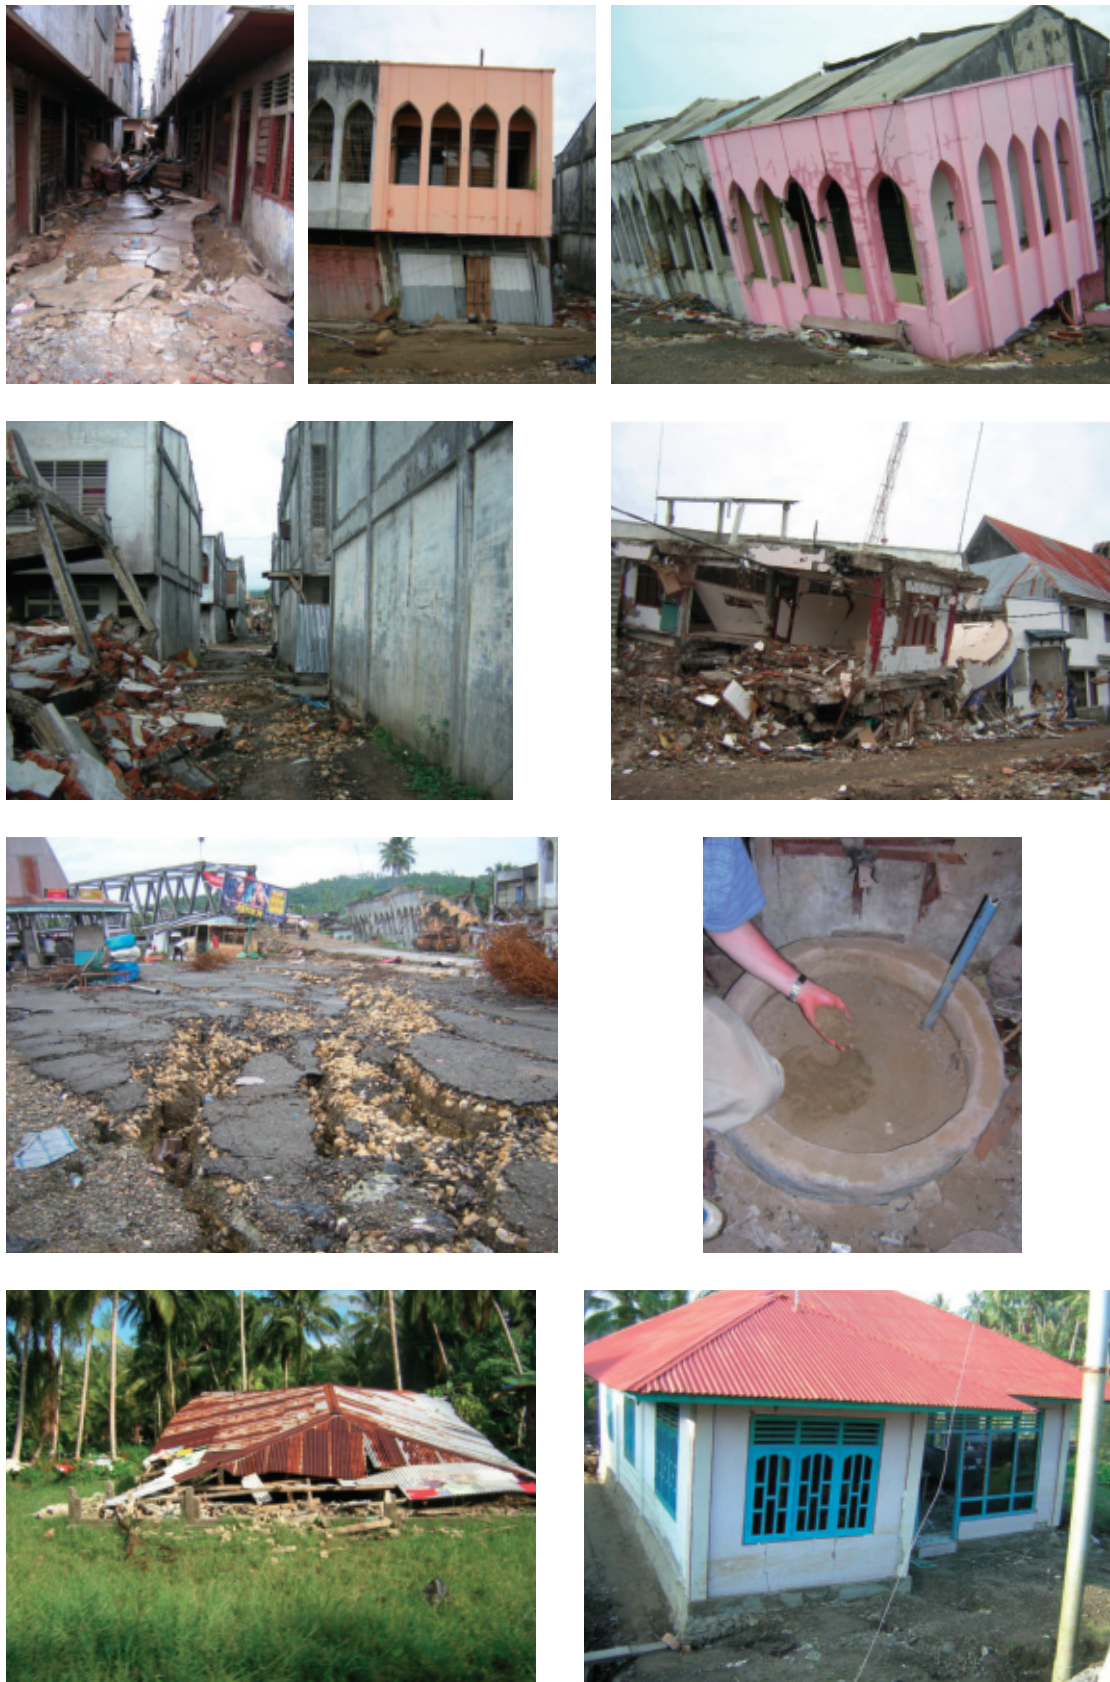
The causes (a) and (b) should be generally regarded as site effects and local ground conditions, which affected residential apartment buildings in the region. Although it is not known exactly, the 15-20 percent of damaged buildings in the Gunung Sitoli either settled up to 1m or tilted and toppled due to ground liquefaction and associated lateral spreading (Figure 9). Due to high level of underground water table and liquefaction of the ground, buildings without raft foundations and continuous tie beams could not resist to ground failures unless they are built on piles extending into the non-liquefiable layers. Compared to those of December 26 2004 earthquake, so many buildings were affected due to the liquefaction in this earthquake.

The reclaimed area in the coastal region of Gunung Sitoli was strongly affected by the quake. Along the shore of Gunung Sitoli, settlement and lateral spreading of ground occurred. As a result, many buildings in a zone for a distance of about 800m from the shore were partially settled and dilapidated (Figures 9). At Fofold along the northern shore of Nias Island, even single story buildings were heavily damaged. The ground was wavy and sand volcanoes could be observed around the area. Although the trace of sand boiling could not be seen on ground at Telukdalam, many RC buildings along the shore were collapsed or damaged. Similar events were also observed along riverbanks.

**Figure 9** Effects of liquefaction and lateral spreading on RC buildings

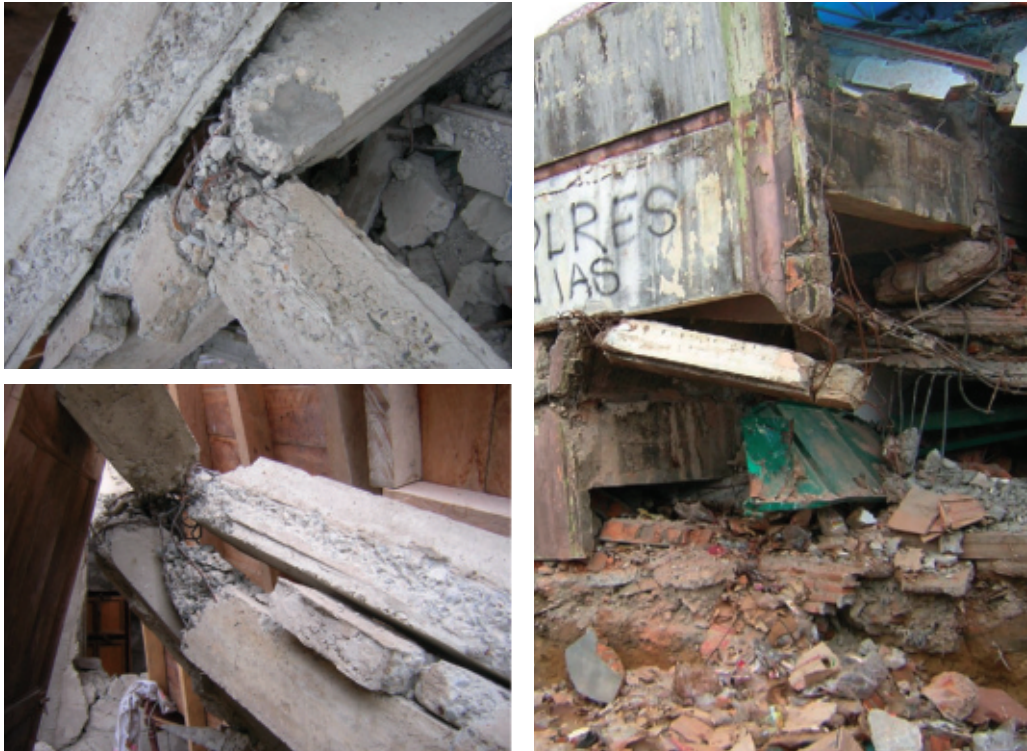
The poor construction quality and structural design problems should be cited as one of the causes of heavy damage to buildings. The spacing of stirrups was too large and they were too thin for (a) shear resistance and (b) confinement of concrete. Spacing is generally 200 mm or larger for a column even at the column ends and their diameter is 8mm. Furthermore the hoops of stirrups are bent 90-degree instead of required 135-degree bent by the modern seismic design codes. As a result the stirrups become loose following the spalling of concrete cover. The spacing of stirrups at member ends for instance in for a shear wall is more than, 200mm, which is too large for preventing diagonal shear crack formation). Although seismic codes require cross ties to confine the concrete, they were non-existent in almost all collapsed RC buildings. Beam-column joints were not designed to transfer shear force and no lateral reinforcement was placed in these joints. Figure 10 clearly shows one of the causes of the heavy damage to RC buildings and illustrates the plastic hinge occurrence at the joint. The ductility provided by the members and the connections was apparently not sufficient to resist such high-level reversed cyclic earthquake loadings and imposed large deformations.

**Figure 10** Typical poorly constructed column-beam joints

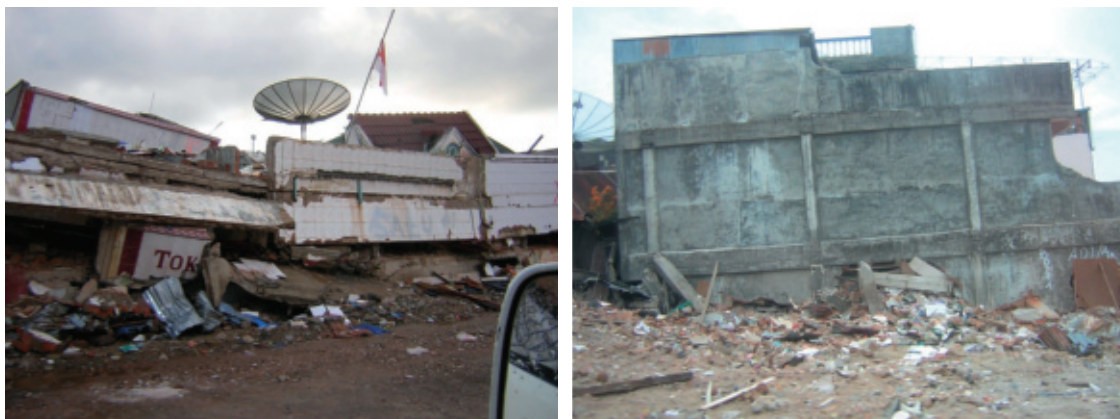
ground floor. Since there are generally no shear-walls to take up the load during earthquakes, the total load is transferred onto the columns. The super structure acts a top-heavy structure on the columns and in-fill walls, which are in poor contact with columns and beams, has no effect against the earthquake loading and they fail subsequently as seen in Figure 11.

**Figure 11** Failure of buildings due to soft floor effect

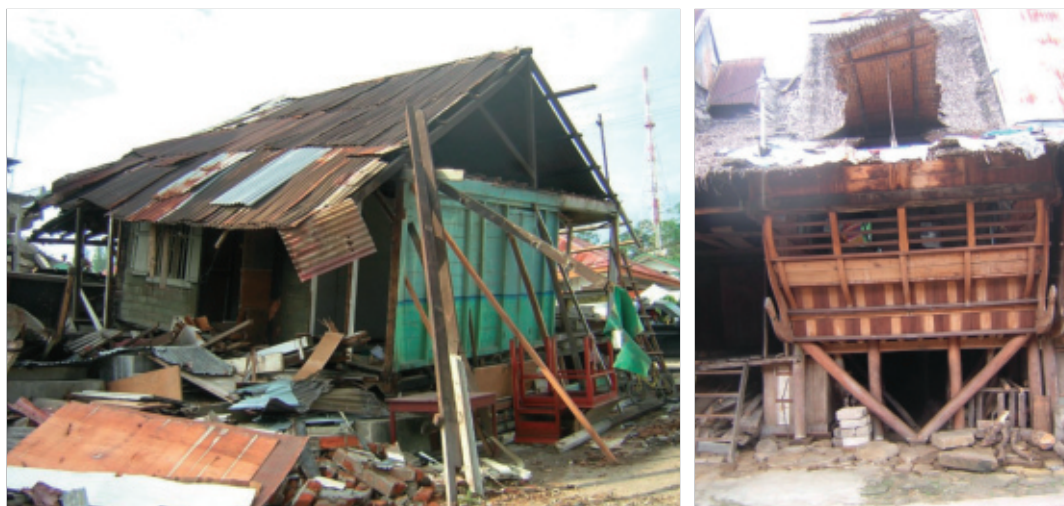
**Figure 12** Damage to wooden houses and schools

wooden houses was mainly caused by the dilapidation of super structure as a result of differential settlement and lateral spreading of liquefied ground and landslides (Figure 12).

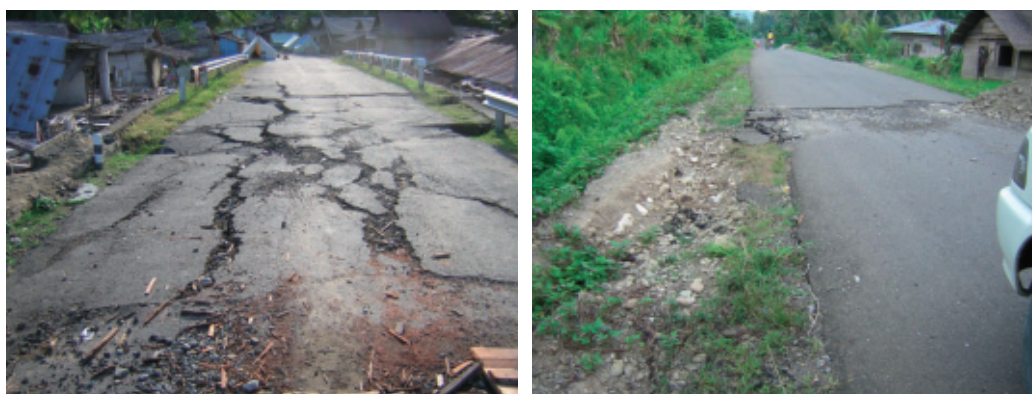
Roadways are generally narrow (less than 5m) and the asphalt surfacing of roadways is generally in poor condition having many potholes. Besides the poor condition of the asphalt surfacing of roadways, the damage was caused by landslides, lateral spreading of liquefied ground, embankment failure (Figure 13). The cracks on the roadway pavement were either longitudinal or perpendicular or both to the road alignment. Longitudinal cracking was generally associated with lateral dilation of roadway embankment. Perpendicular cracking to the road alignment was generally observed nearby bridge abutments due to lateral spreading of ground. However, such cracking was also observed in areas, which are non-affected either by landslides or lateral spreading. Although the reason is still unknown, a possible explanation may be related to the fracture propagation during faulting.

**Figure 13** Damage to roadways

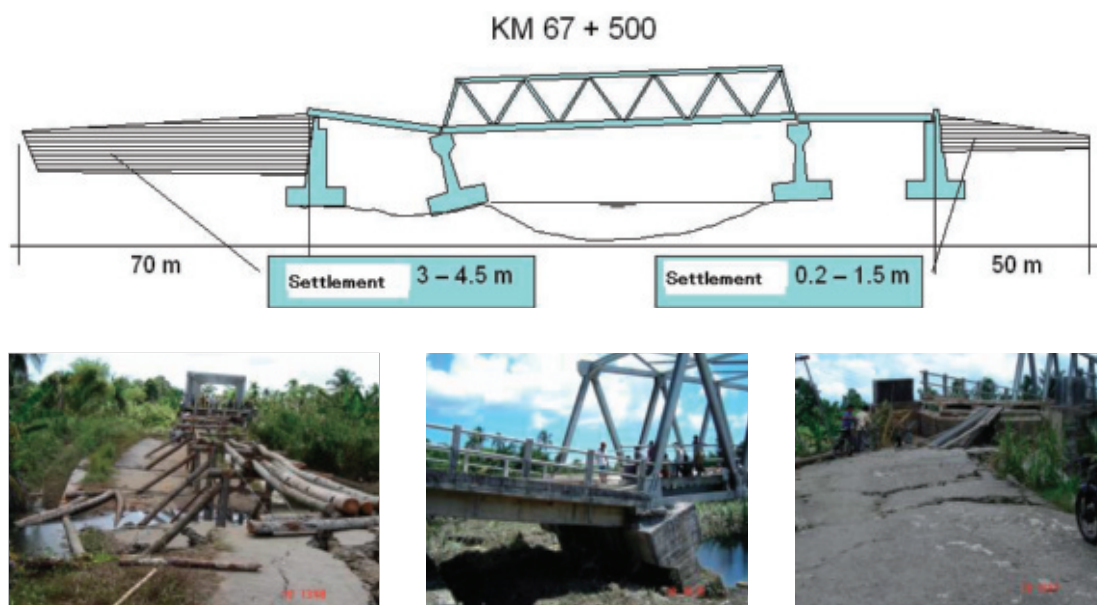
Bridges, d) Wooden paved steel framed bridges, and e) Wooden bridges. Long span bridges are either truss bridges or RC bridges with or without box culverts. The bridges are designed as simple-supported structures. The bearing supports of many bridges do not have shear-keys or stoppers against both horizontal and vertical movements. The heavily damaged non-accessible large bridges within the surveyed area are Muzoi Bridge between Gunung Sitoli and Lahewa route and Gawo Bridge between Gunung Sitoli and Telukdalam nearby Tetelesi. These bridges consist of truss super-structures and RC box culverts. Muzoi Bridge were tilted and settled due to bearing capacity and lateral spreading problems associated with liquefaction of ground (Figure 14). The engineers of Department of Public Works pointed out that piers have piles reaching rock formation. It seems that the piles were designed against vertical loads and horizontal loads were not considered. The ground is laterally moved towards the river, which can be clearly inferred from the tilted electric poles next to the bridge and the lateral movement of the ground was more than 4m on both sides.

**Figure 14** A sketch of Muzoi River Bridge and some views of its present state

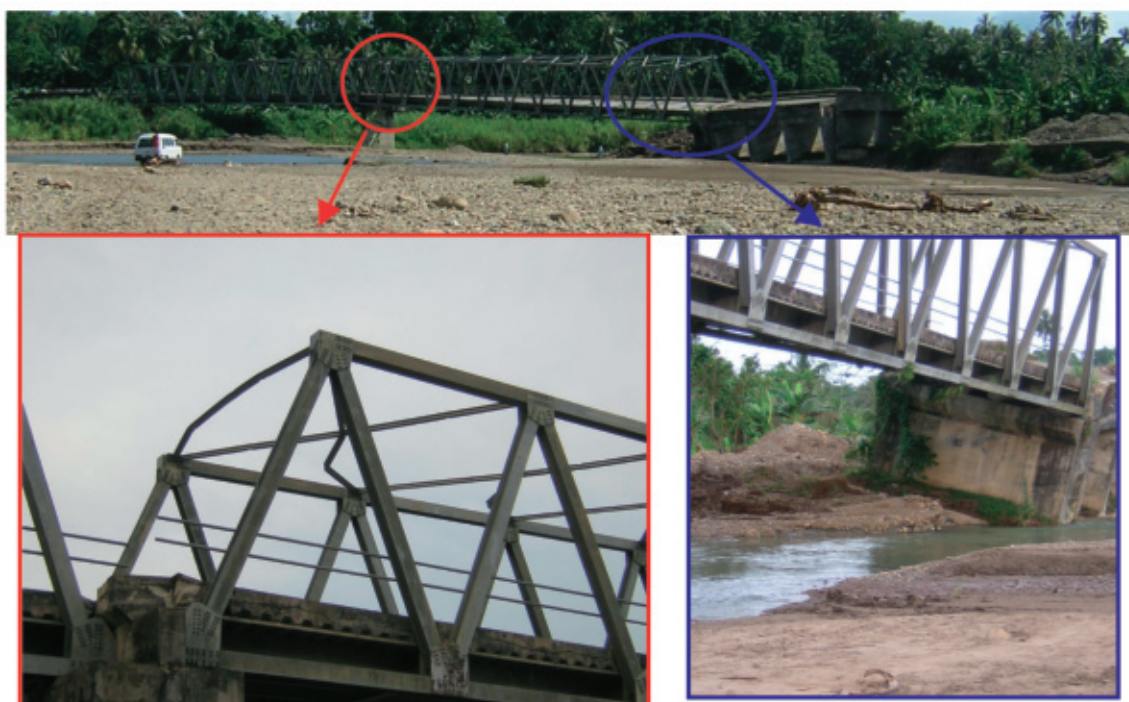
The second pier of Gawo Bridge was tilted and slid towards the upstream side of the river and the box-culvert to this pier was also tilted and slid together with the pier (Figure 15). The upper deck of the truss section of the bridge is horizontally shifted about 1.3m. The piers were constructed without using pile foundations. The site investigation indicated that there is a mudstone-like layer and overlaying soil layers consist of sand,

gravel and sandy-silt from bottom to top (Figure 16(a)). These layers are tilted towards upstream side with an inclination of 5–10 degrees. Furthermore, the river flow is directed towards the pier and box-culvert. Although the construction details of the pier and box culvert are not known, it seems that the toe erosion (scouring) of the pier and box culvert together with liquefaction of inclined sandy layer and horizontal shaking may be the major causes of the damage to Gawo bridge.

**Figure 15** Gawo Bridge nearby Tetelesi

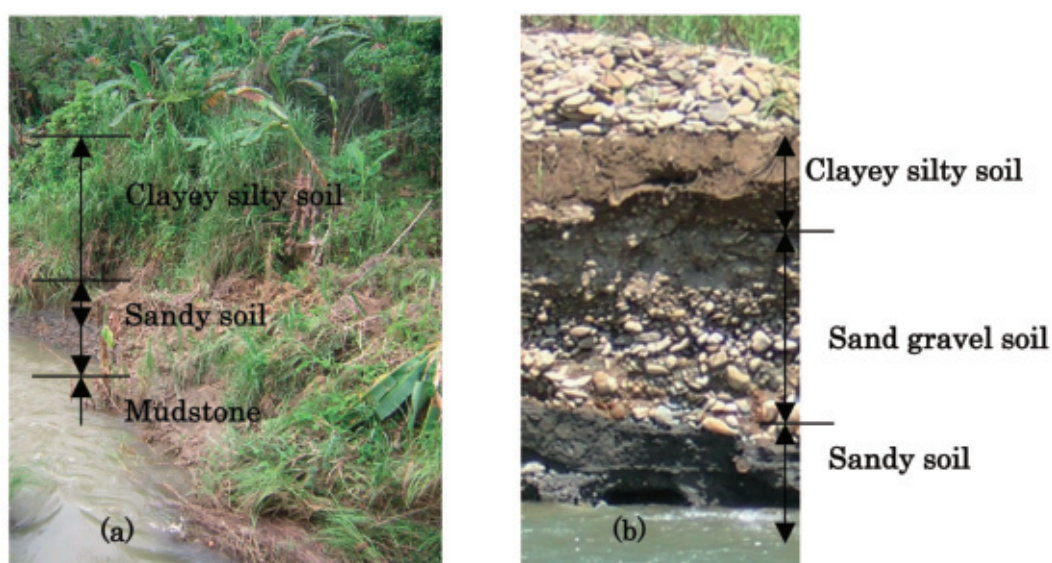
**Figure 16** Typical soil conditions at the abutments of bridges

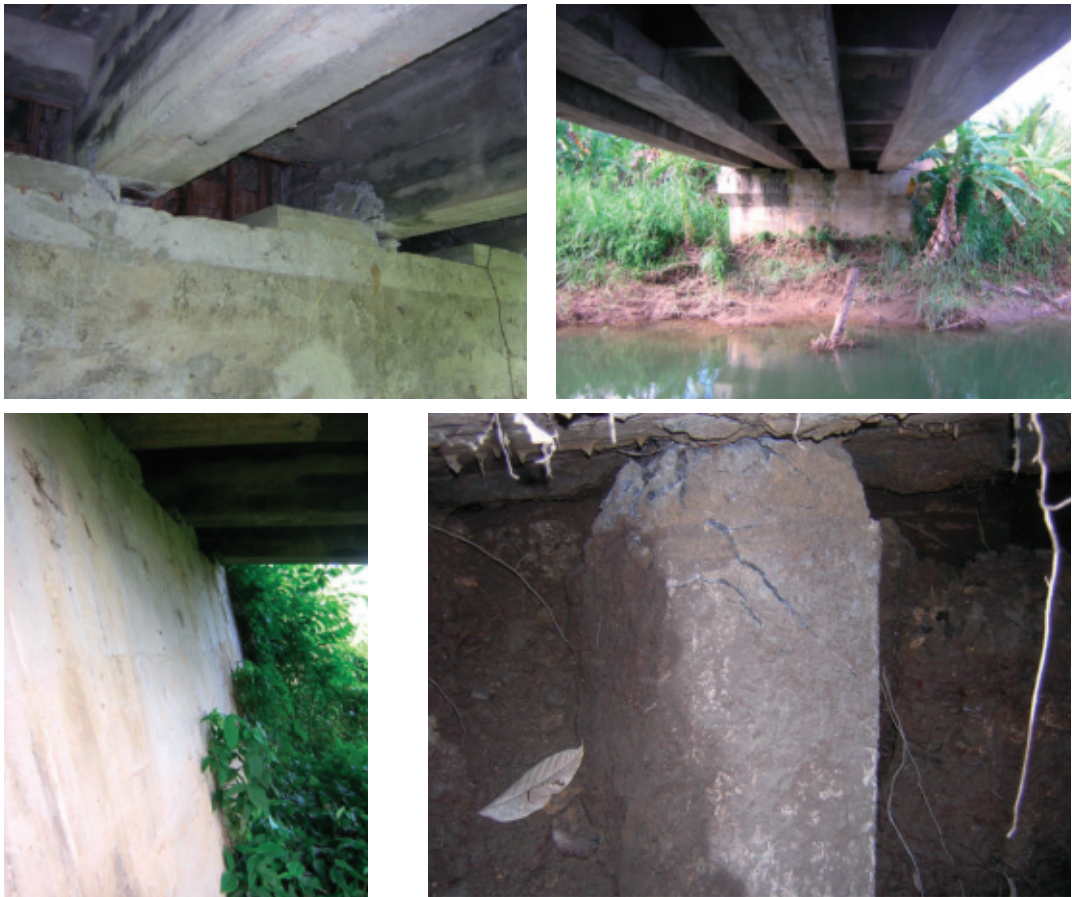
The lateral spreading of liquefied ground damaged RC bridges in Gunung Sitoli town. The bridge foundations have some piles and some of these piles were broken at the top (Figure 17). Many truss bridges along Gunung-Sitoli and Telukdalam route were damaged by permanent movement of abutments as a result of lateral spreading of liquefied ground. The ground consists of mudstone-like layer, sand layer and clayey-silty soil and top organic soil (Figure 16(b)). Sandy layer is generally found at the water level of river and it is expected to be full saturated. During earthquake shaking, it seems that this sandy layer is liquefied and caused the lateral spreading of ground. The lateral spreading of ground was particularly amplified on the convex side of the riverbank as the ground can freely move towards the river. These movements caused high lateral forces on the abutments, which caused the sliding and tilting of piers or fractured the piles of the abutments of truss bridges. Similar situations are also observed on RC bridges.

Figure 17 Some examples of damage to RC bridges

The damaged bridges generally need to be re-constructed and it should be next to existing piers with necessary geotechnical investigation of ground and its characteristics. The present truss decks can be used in the new-constructions with some replacement of damaged elements and bolts and bearings together with appropriate stopper against horizontal and vertical relative movements.

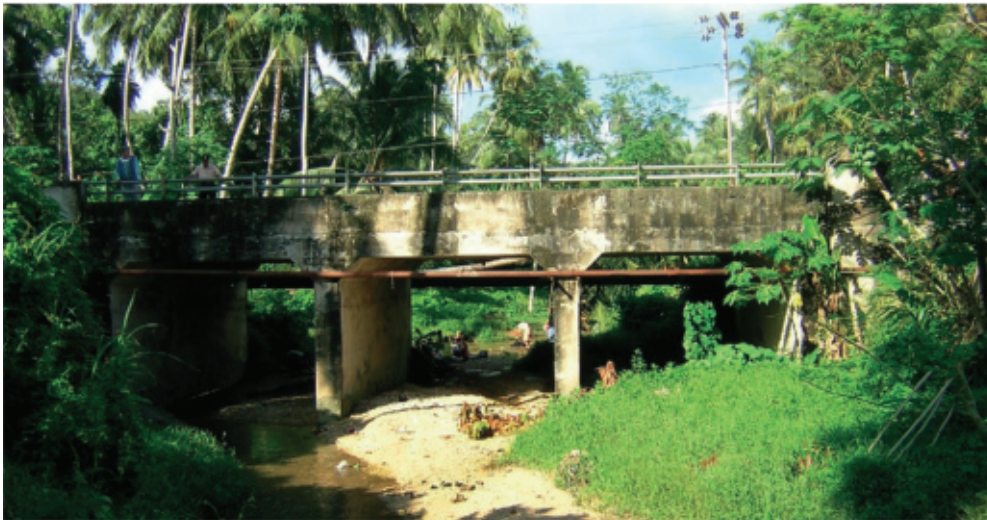
Box culvert bridges generally performed well during the earthquake except locations where scouring or ground settlement occurred (Figure 18).

Figure 18 Non-damaged RC box culvert

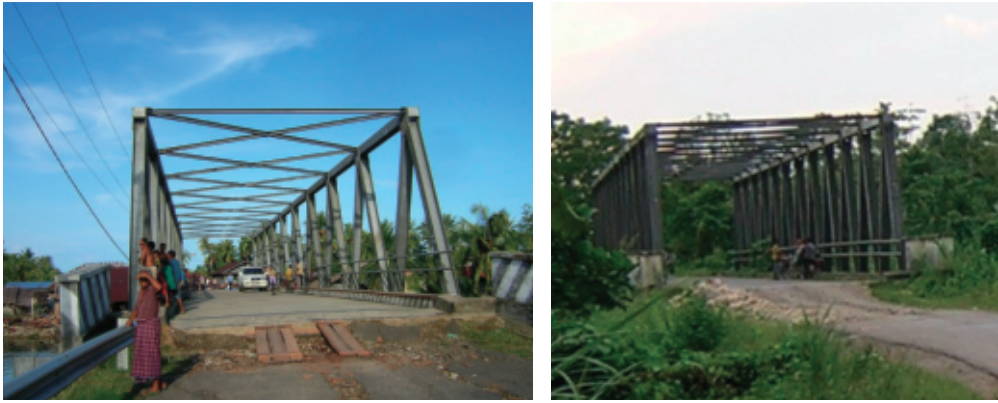
The approach embankments of bridges are generally damaged and settled due to lateral spreading of ground and failure of wing-embankment walls. The settlements were generally greater than 30cm in many locations (Figure 19). The backfill materials of approach embankments consist of gravelly soil and it is expected that the potential of settlement or liquefaction is low.

**Figure 19** Settlement of approach embankments of bridges

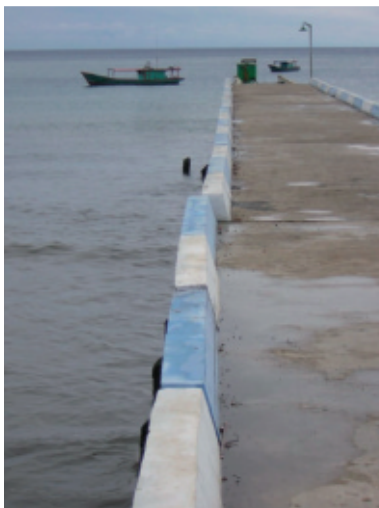
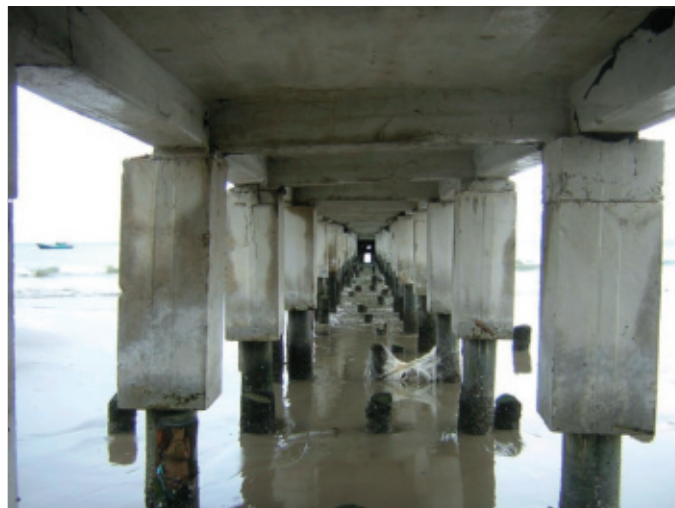
There is some damage to port facilities in Nias Island due to ground shaking rather than tsunami (Figure 20). The lateral spreading of liquefied ground damaged the new wharf of Gunung Sitoli port. As a result, the pile

heads fractured and settled. Furthermore, there was a relative movement of 15cm between the sections of the wharf. In Telukdalam new port, a part of wharf sank into the sea and some pile heads were fractured by collision of wharf segments.

(a) Damage at Gunung Sutoli port

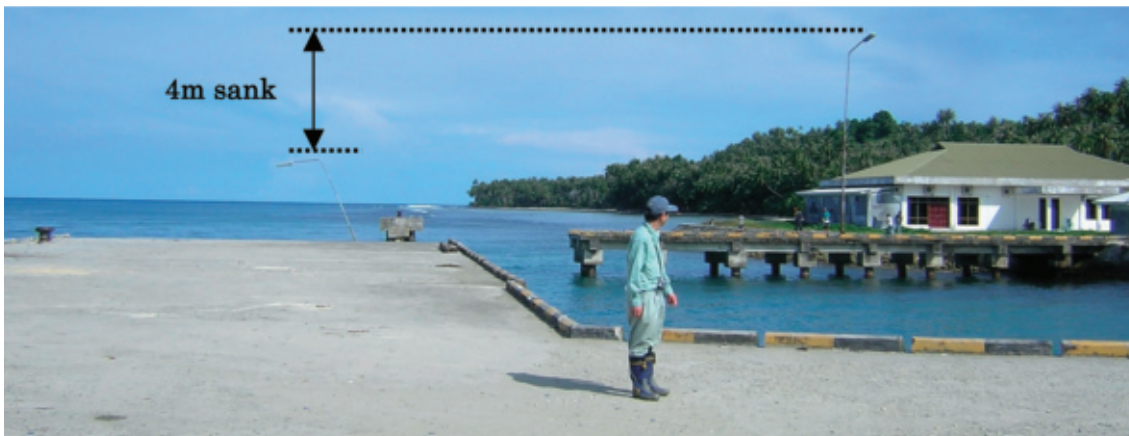
(b) Sank part of the wharf at Telukdalam new port

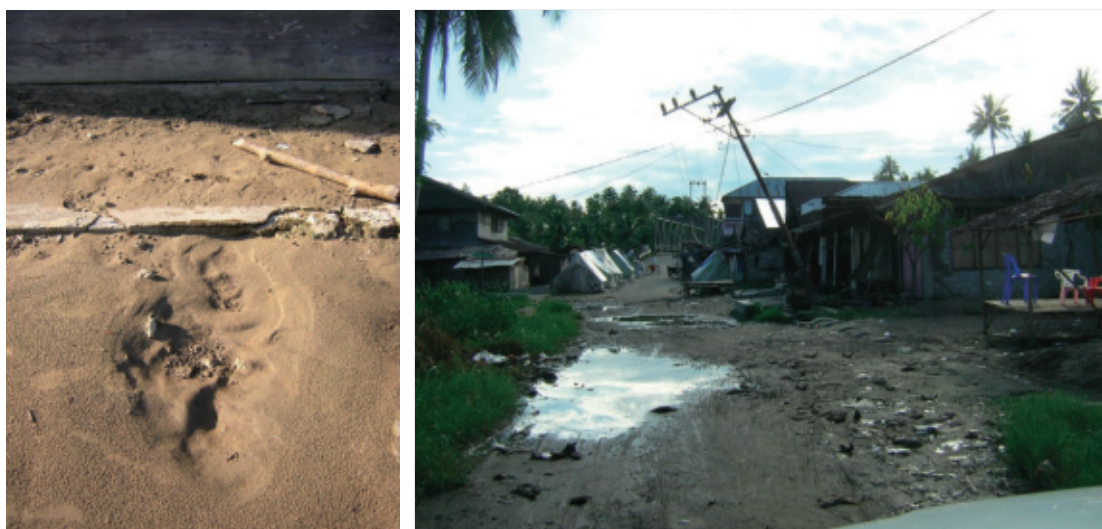
As expected from the magnitude of this earthquake, the liquefaction of sandy ground is very likely. Seashore and riverbanks were generally consisted of sandy ground. The traces of ground liquefactions were observed in various locations along the inspected routes. Figures 9 and 21 show some examples of ground liquefaction. The all possible forms of ground movements and the effects of ground liquefaction were observed such as sand boils, lateral ground movements, settlement. The damage induced in Gunung Sitoli is widespread along the coastal area and reclaimed ground and in other coastal towns. The lateral spreading of ground nearby bridge abutments was almost entirely associated with liquefaction of sandy soil layer as shown in Figure 16. However, the geotechnical investigations of ground are lacking in Nias Island and it would be desirable to carry out such investigations for areas particularly affected by ground liquefaction are necessary.

**Figure 21** Some examples of sandboils in Gunung Sitoli and coastal areas
