# The Characteristics of the 2008 Wenchuan Earthquake Disaster with a Special Emphasis on Rock Slope Failures, Quake Lakes and Damage to Tunnels

Ömer AYDAN<sup>\*1</sup>, Yoshimi OHTA<sup>\*2</sup>, Masanori HAMADA<sup>\*3</sup>,  
Jun ITOH<sup>\*4</sup> and Katsumi OHKUBO<sup>\*5</sup>

## Abstract

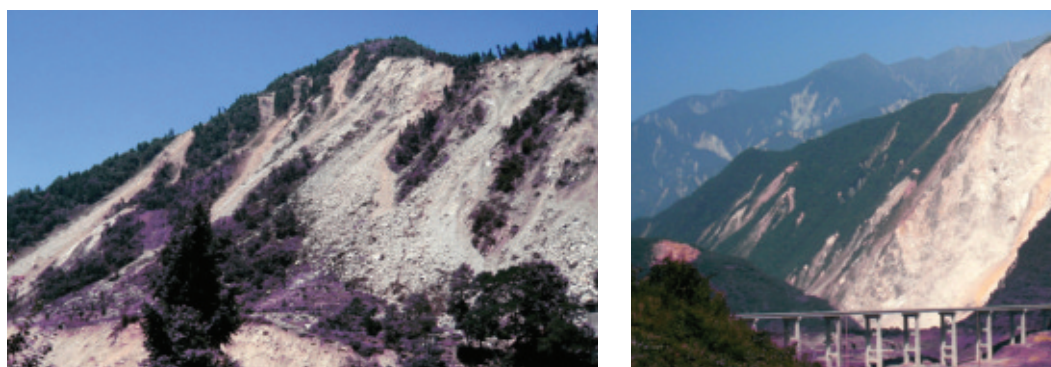
**Figure 6.** Spectacular surficial rock slope failures

slate, sandstone, mudstone, shale and limestone. Particularly reddish mudstone and brackish shale are very prone to weathering. Furthermore, the rocks at higher elevations are also subjected to thawing and freezing as well as other atmospheric conditions. Most of these rock units contain joints, bedding or schistosity planes as well as fracture zones due to intense tectonism associated with Longmenshan fault zone. In addition, the limestone is very prone to solution by percolating ground water along fractures and they contain many solution cavities. Figure 6 shows several surficial slope failures in limestone unit in the vicinity of the Weizhou and the Zipingpu dam site. The surficial slope failures in limestone unit was spectacular and continued for several kilometers as they are clearly noticed in satellite images.

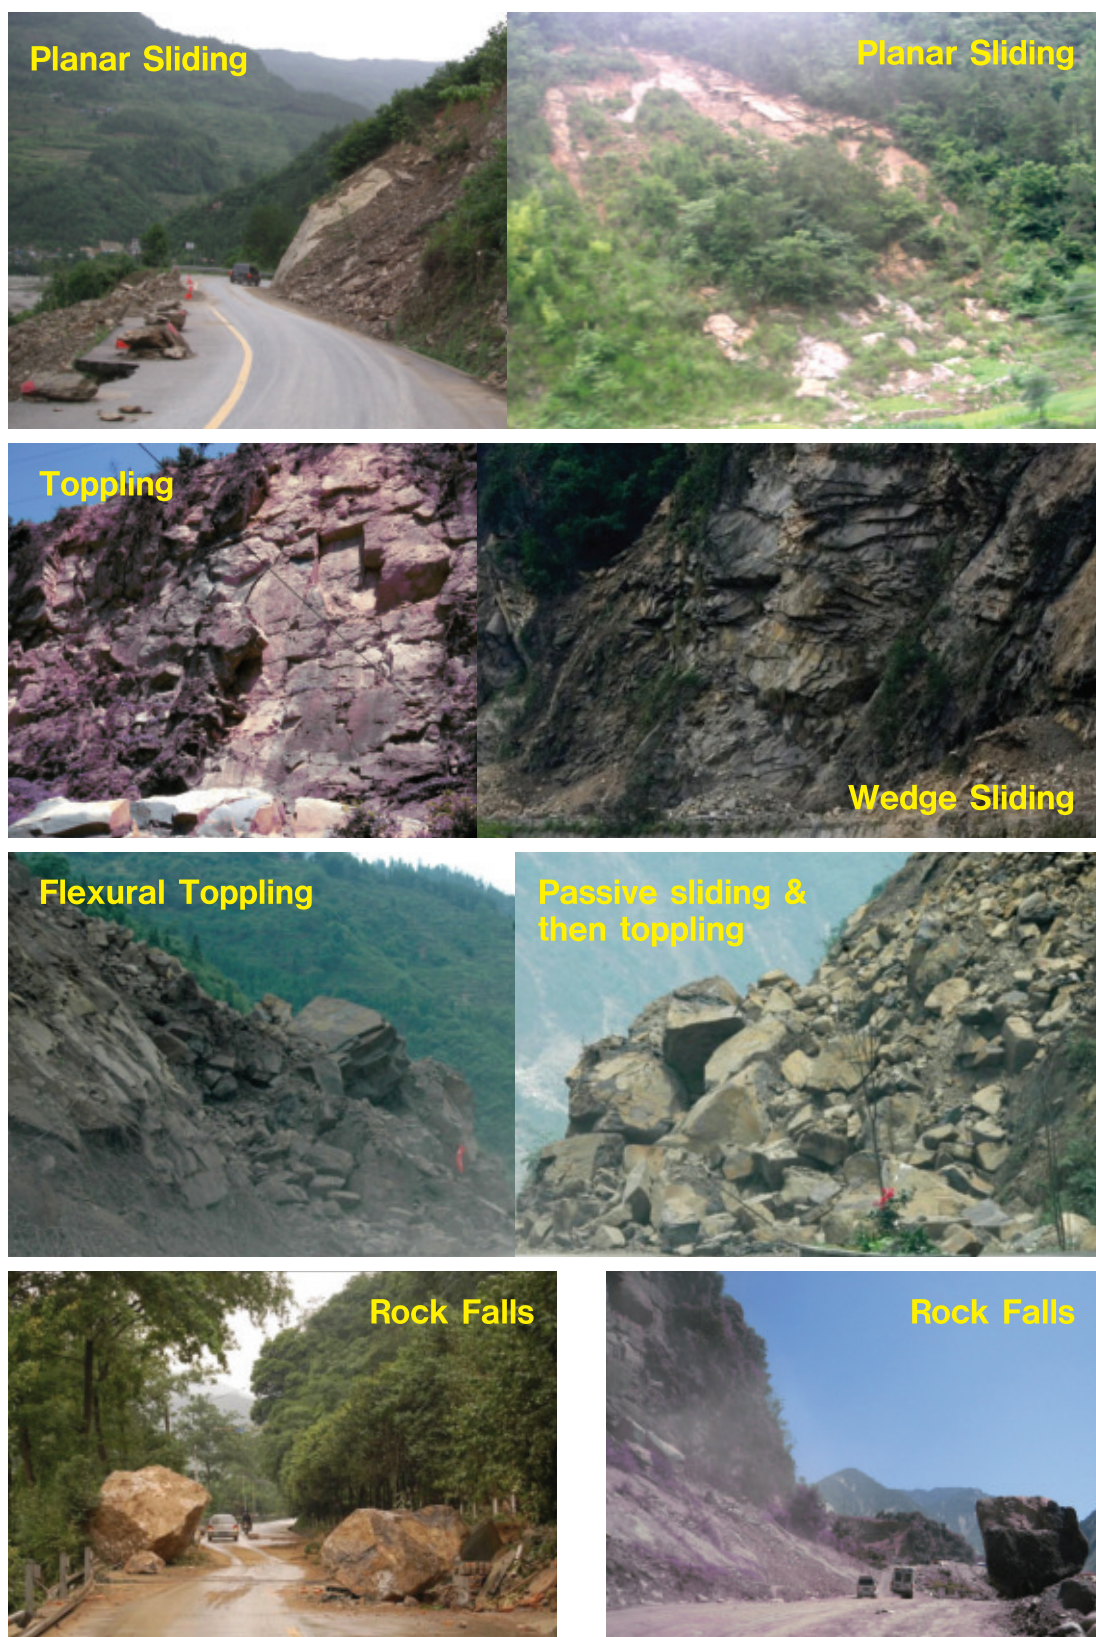
As said above, rock units are phyllite or slate, sandstone, mudstone, shale and limestone. Geologically, granitic unit exist in the epicentral area. However, the authors did not have chance to see such sites. Except granite, all rock unit has at least one throughgoing discontinuity set, namely, bedding plane or schistosity plane. Since rock units had been folded, they also include joint sets and fracture planes as a result of tectonic movements. Furthermore, the measurements on faults in limestone outcrops in the vicinity of Miaoziqing bridge indicated three dominant faults, which divide the limestone unit into large blocks. Granite generally has at least three discontinuity sets. In regard with rock slope failures classified in Figures 4 and 5, the rock slope failures are mainly planar sliding, flexural or block toppling failure (Figure 7). In addition, passive sliding and toppling failures were observed in intercalated sandstone and shale units. Active planar sliding failures were probably much larger in scale as compared with other slope failures. Several large scale slope failures will be presented and discussed in next sub-section. Rockfalls in the epicentral area are generally result of the toppling of rock blocks due to excitation of the earthquake. Numerous rockfalls were observed for a great length of roadways. Rockfalls were common in sandstone and limestone slopes, which caused a huge number of vehicle crushing events resulting in heavy casualties.

**Figure 7.** Some examples of rock slope failures and rock falls

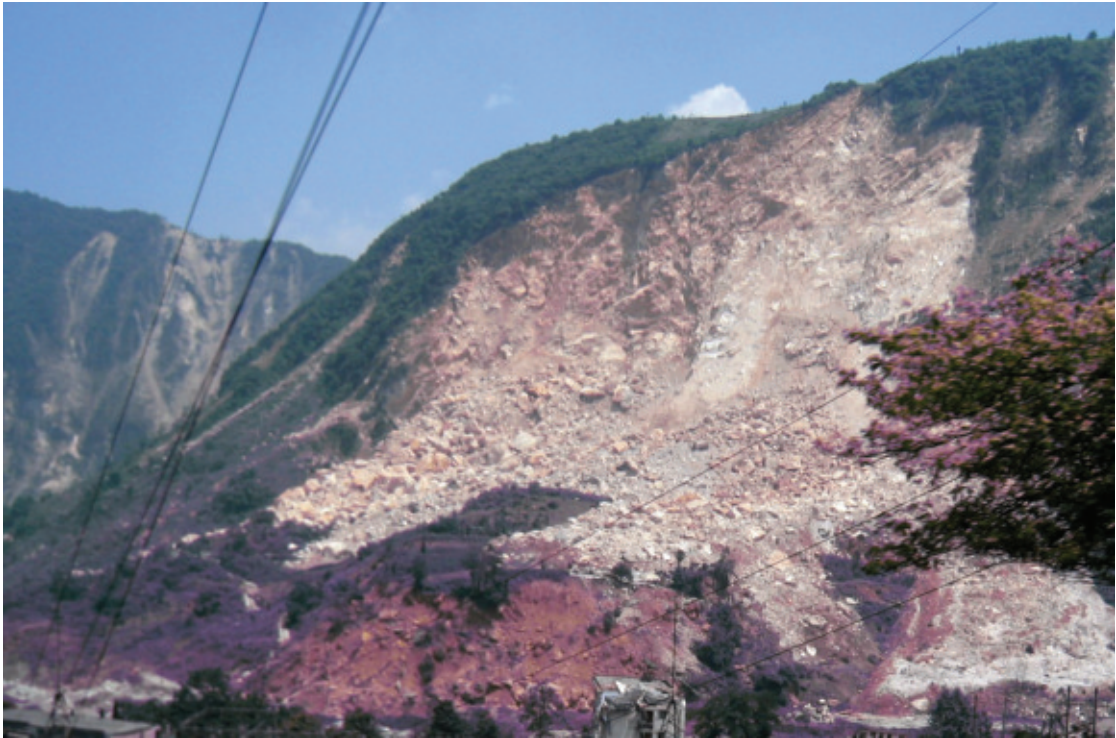
The Yingxiu landslide (Figure 8) involved mainly limestone, which dips to the valley side with an inclination of 20–25°. Furthermore, there is a fault dipping parallel to the failure surface within the rock mass. The angles of the lower and upper parts of the failed slope are 60° and 30°, respectively. In addition to this new landslide, one can easily notice the existence of a paleo-landslide in the fore-ground. The failure plane of this slope failure or landslide is bi-planar and it involved the fault and bedding plane. The fault plane probably assisted the separation of the failed body from the rest of the mountain. The in-situ tilting tests on the limestone joint surfaces yielded the friction angle as 38–42°. If the resistance is purely frictional the expected lateral horizontal seismic coefficient should be greater than 0.36g. Since Yingxiu town was heavily damaged by this earthquake, it is more likely that such a high ground acceleration did act on this slope.

Figure 8. A view of the Xuankou (Yingxiu) landslide

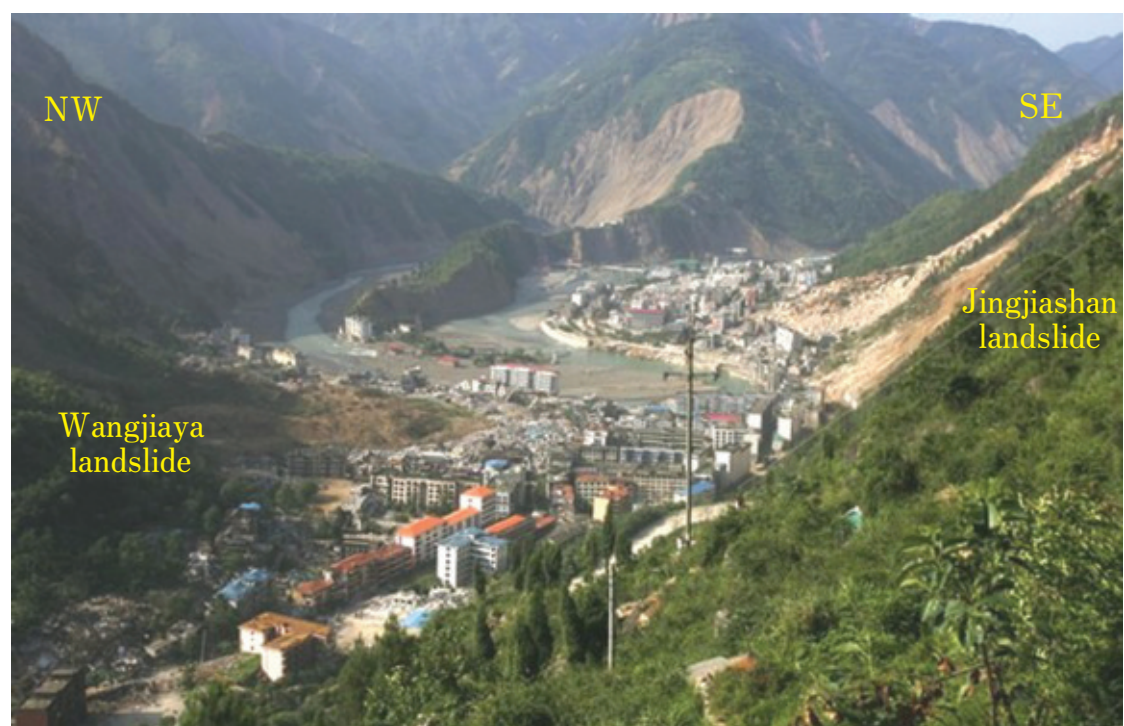
**Figure 11.** Views of landslides in Beichuan

the failed slope are  $60^\circ$  and  $30-35^\circ$ , respectively. The existence of several faults dipping parallel to the slope with an inclination of about  $60-65^\circ$  creates a stepped failure surface. If the resistance is assumed to be purely frictional the expected lateral horizontal seismic coefficient should be greater than 0.18g.

The SE facing slope (Wangjiaya landslide) may involve a slippage along the steeply dipping discontinuity plane (fault plane?) and shearing through the folded rock mass. In other words, it may be classified as a combined sliding and shearing failure (Aydan *et al.* 1994). The angles of the lower and upper parts of the failed slope are  $40-45^\circ$  and  $30-35^\circ$ , respectively. The layers dip at angle of  $40^\circ$  towards the valley and shearing plane is inclined at an angle of  $20^\circ$ . Since material properties and conditions of rock mass are not well-known for this site yet, no estimation for possible ground acceleration has been done. Nevertheless, it is more likely that such a high ground acceleration did act on this slope since Beichuan town was heavily damaged by this earthquake.

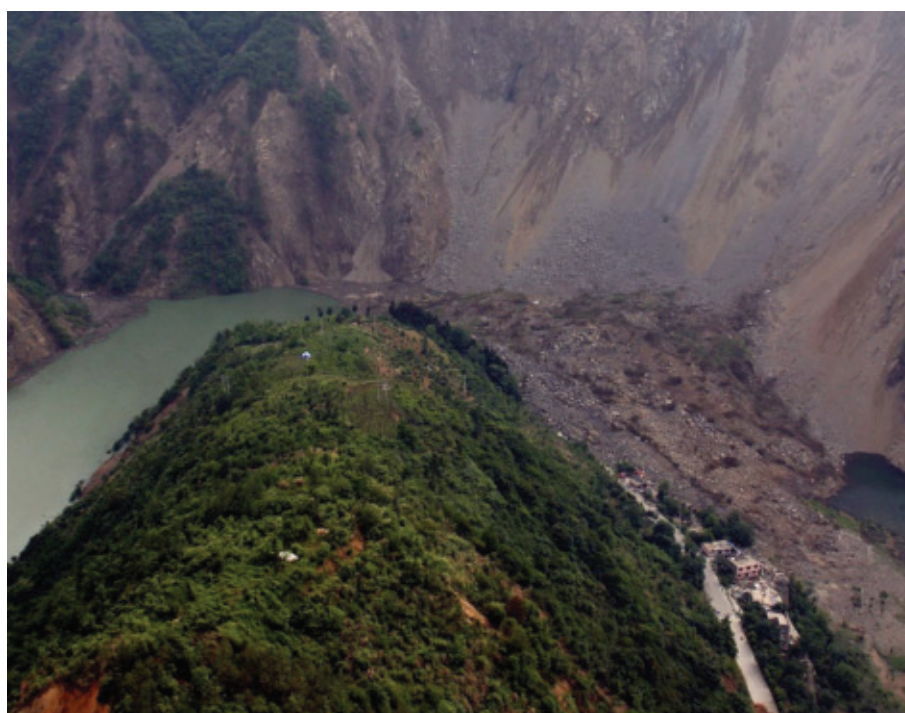
Tangjiashan landslide, which obstructed Jian River, is located about 2km NW of Beichuan (Qushan) town (Figure 12). The landslide faces NW. The rock units involved in this landslide is limestone (top part), and intercalated sandstone and shale (lower part). Rock

layers dip towards the valley at an inclination of  $40-50^\circ$ . Although the upper part of the mountain has a slope angle of  $40-45^\circ$ , the lower part is more steeply inclined up to  $70^\circ$  due to the toe erosion by Jian River. The earthquake induced almost a planar sliding of 600m wide and 450m long body of rock mass. This landslide blocked Jian River for a length of 800m and created a landslide dam with a maximum height of 124m.

**Figure 12.** A view of Tangjiashan landslide (arranged from the image by Xinhuanet)

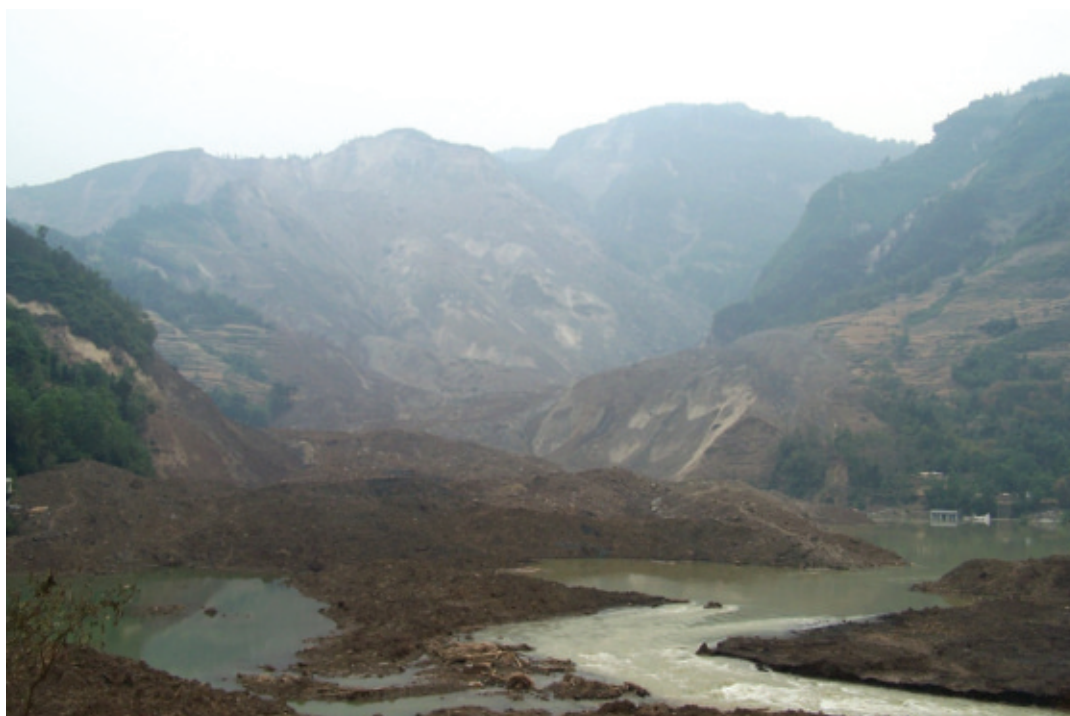
This landslide occurred at Donghekou village of Hongguang Township, Qingchuan County and it is located at the NE tip of the earthquake fault. The upper part of the mountain covered by limestone, below which phyllite exist. This phyllite formation is considerably thick and it is inclined at an angle of  $30-45^\circ$  to NE and it is slightly discordant with upper limestone formation. A paleo landslide exist to the east of the new landslide source area. The in-situ tilting tests on the phyllite schistosity (bedding) plane surfaces yielded the friction angle as  $22-24^\circ$ , which is considerably small. In other words, slopes facing NE can not be stable even under static conditions if the resistance is only frictional. The initial movement of the unstable part of the mountain should have been in NE direction and then its direction of motion rotated towards SW (Figure 13). Further investigations and laboratory tests on samples from this

**Figure 13.** A view of Donghekou landslide in Qingchuan County

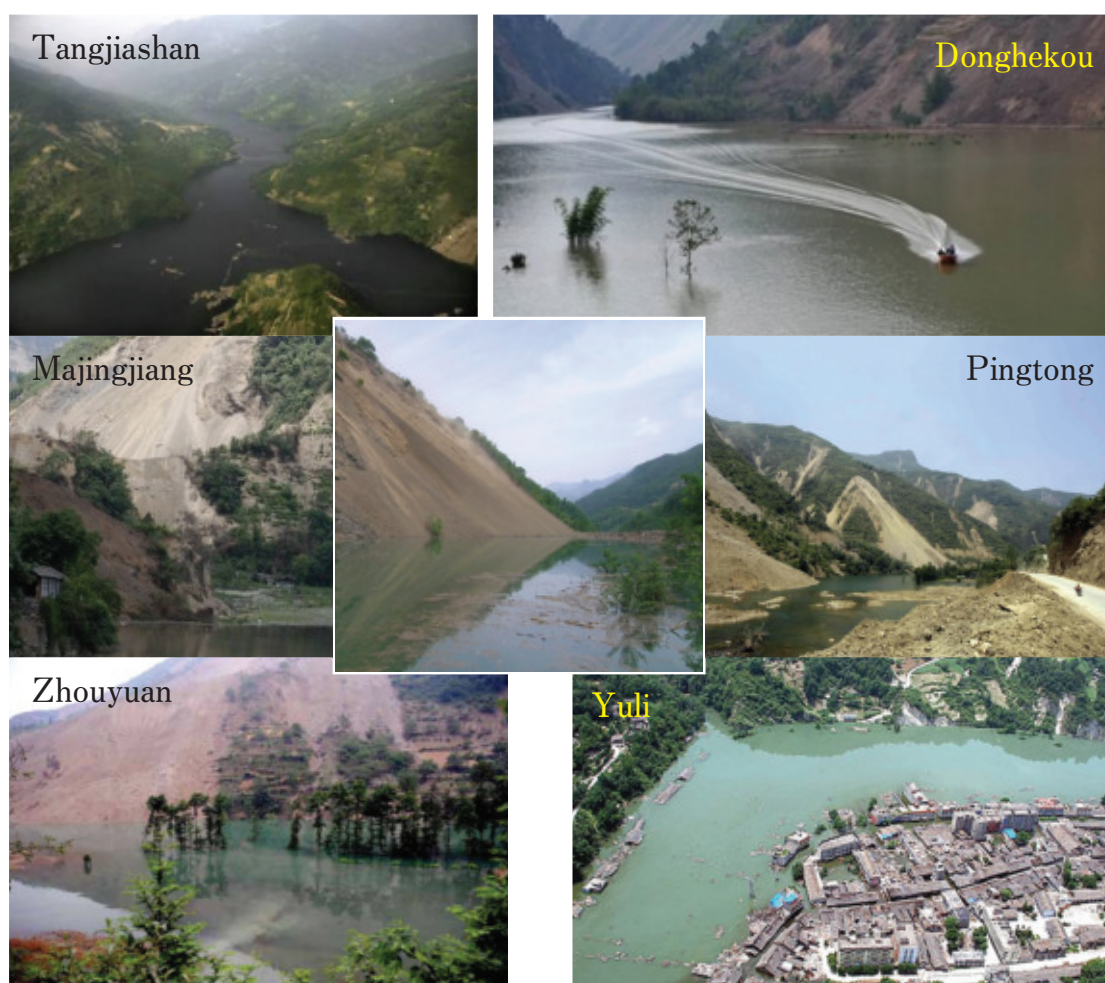
Figure 17. Views of some of quake lakes before breaching (partly from Xinhuanet)

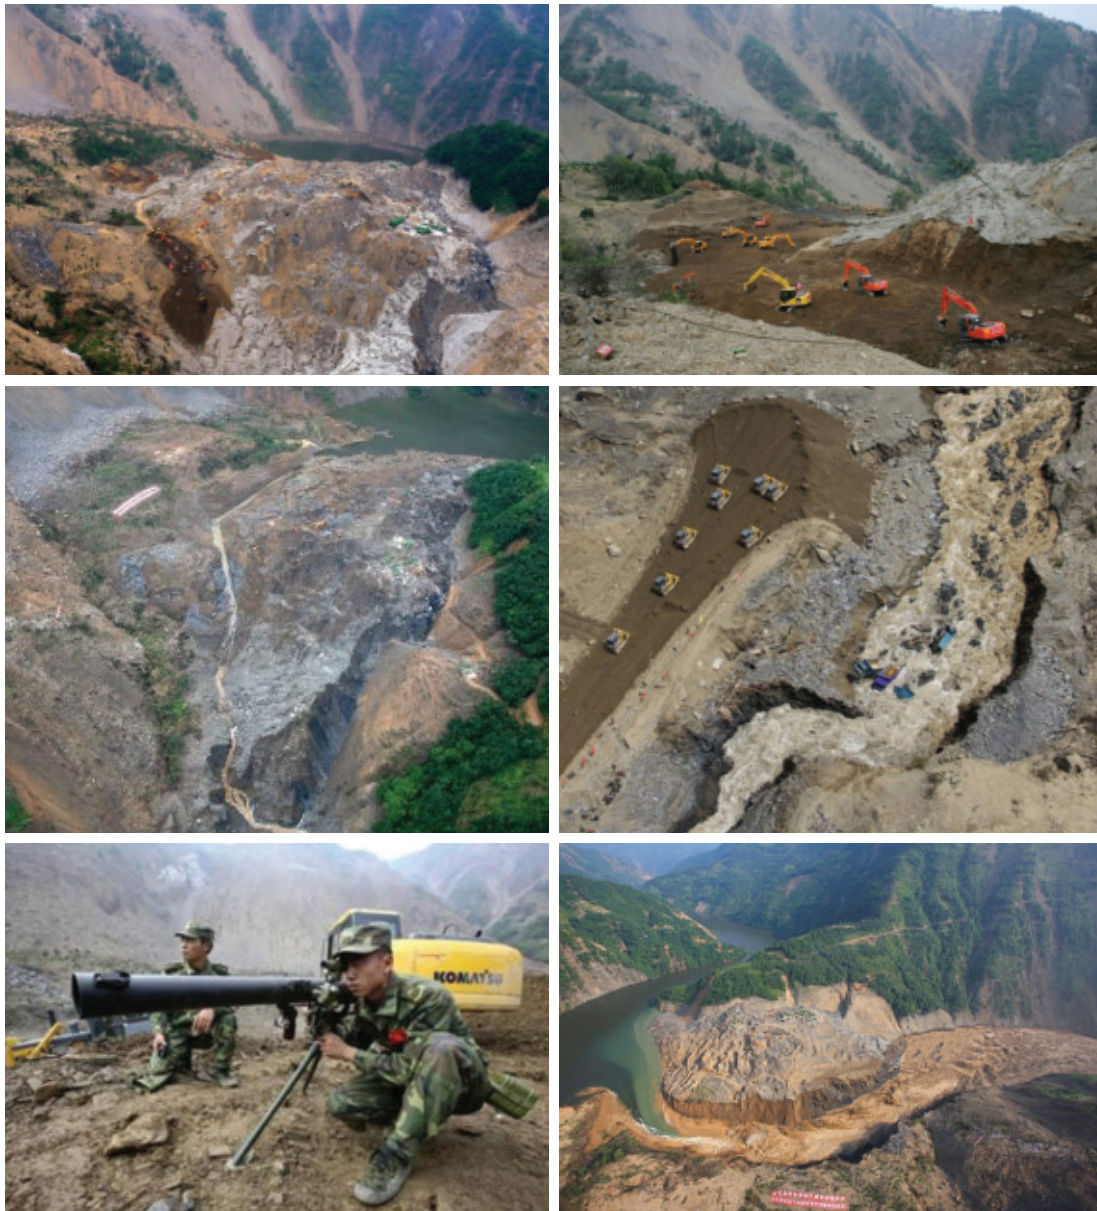
**Figure 18.** Views of several stages of Tangjiashan quake-lake (from Xinhuanet)

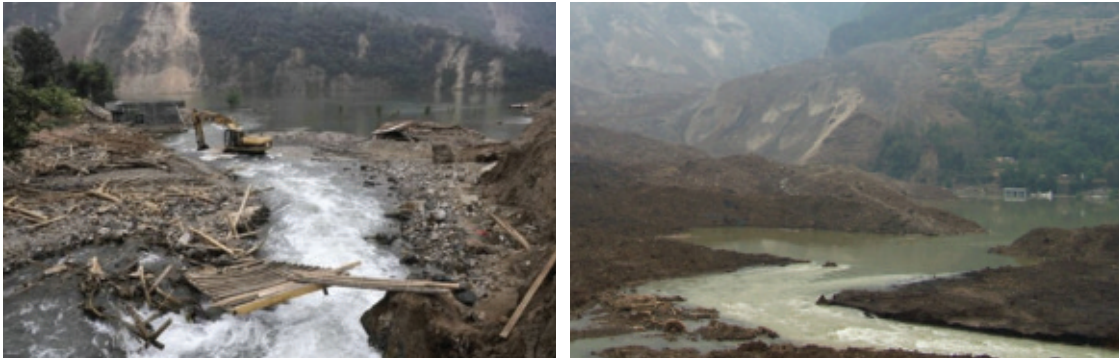
**Figure 20.** Views of the drainage of Donghekou quake-lake

Qingchuan County. This landslide also resulted in two quake lakes. However, these quake lakes were successfully breached using construction machinery as well as blasting technique (Figure 20). The lower quake lake is not fully breached and one can still see the top of electricity utility poles.

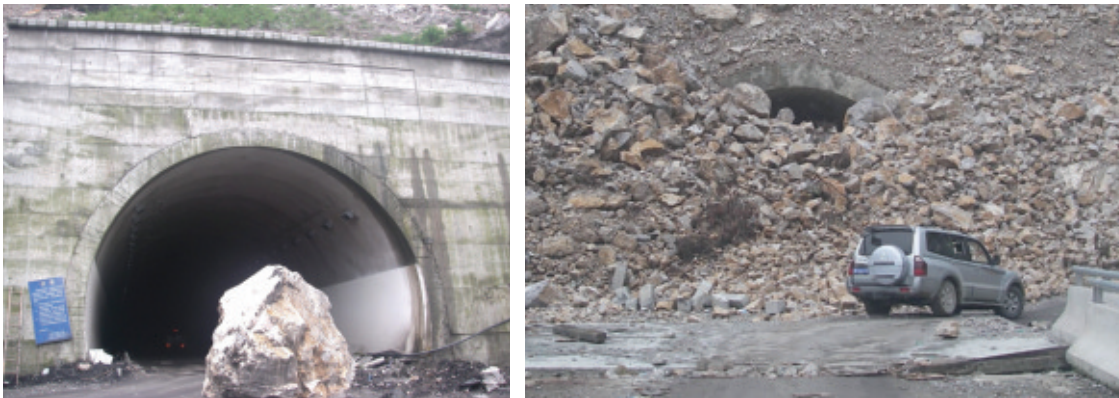
ground shaking is concerned. The damage to tunnels is generally limited to portals, which are mainly caused by slope failures and rockfalls. Several examples of portal damage are shown in Figure 21. Similar damage to portals of railway tunnels was also observed. Nevertheless, such damage is light in scale and did not cause any major structural stability problems so far.

**Figure 21.** Damage to tunnel portals

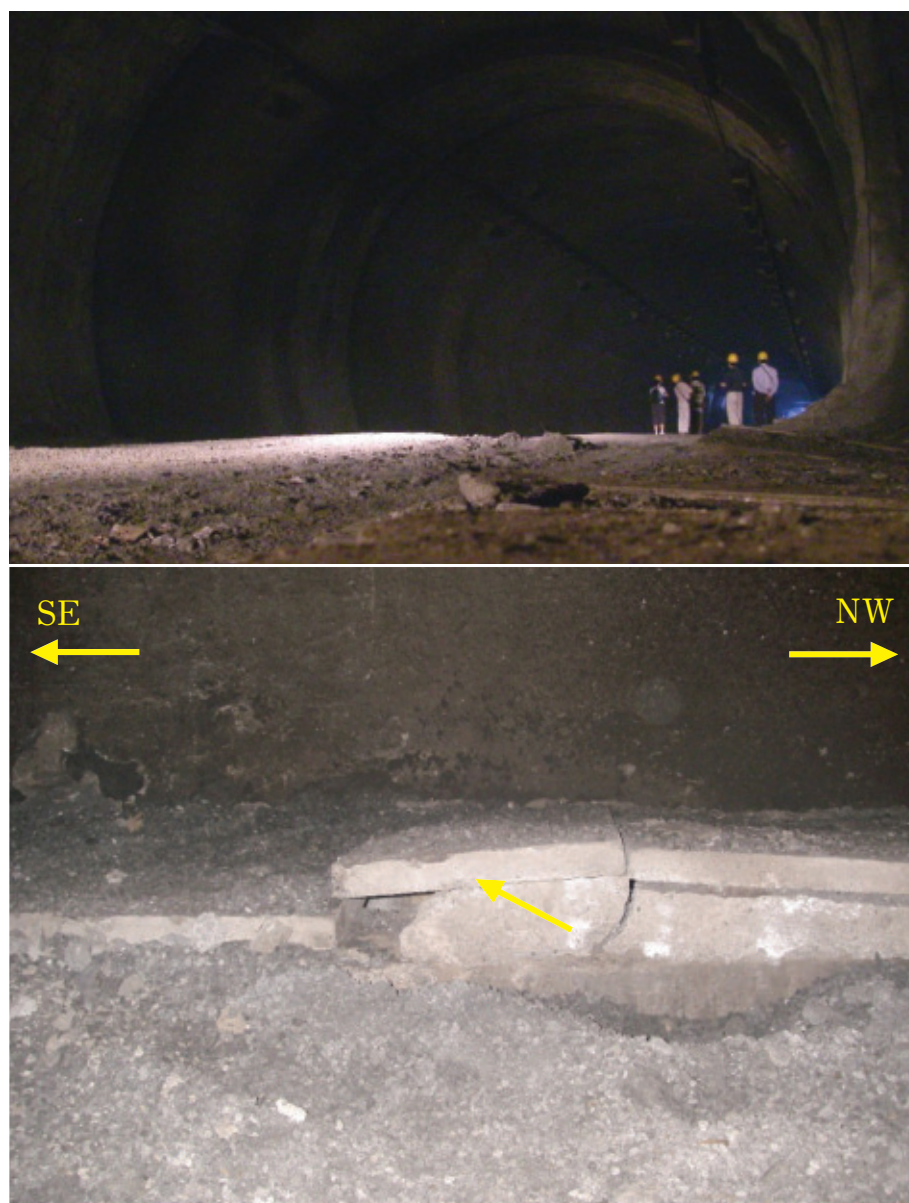
three of which were under construction and suffered heavy damage during the earthquake. The tunnel nearby Zipingpu dam (N31.04888, E103.56463) is a two-lane tunnel with a length of about 1000m. The lining was damaged at several locations perpendicular to its longitudinal axis, which is aligned NW-SE direction. This tunnel was already repaired at the time of the investigation (June 21, 2008) (Figure 22). The tunnel is about 18.

5km away from the earthquake epicenter and it is very close to the Yingxiu-Beichuan fault. The tunnel floor was stepped at the damaged zones implying the NW side is moved upward. Since this earthquake is of great scale and it is relative slip was presumed to be about 7m, it is very natural to expect a diluted deformation zone as the fault approaches the ground surface due to the reduction of vertical stress. The damaged section of the tunnel rebolted and shotcreted.

**Figure 22.** Views of repaired damaged section of the tunnel near the Zipingpu dam

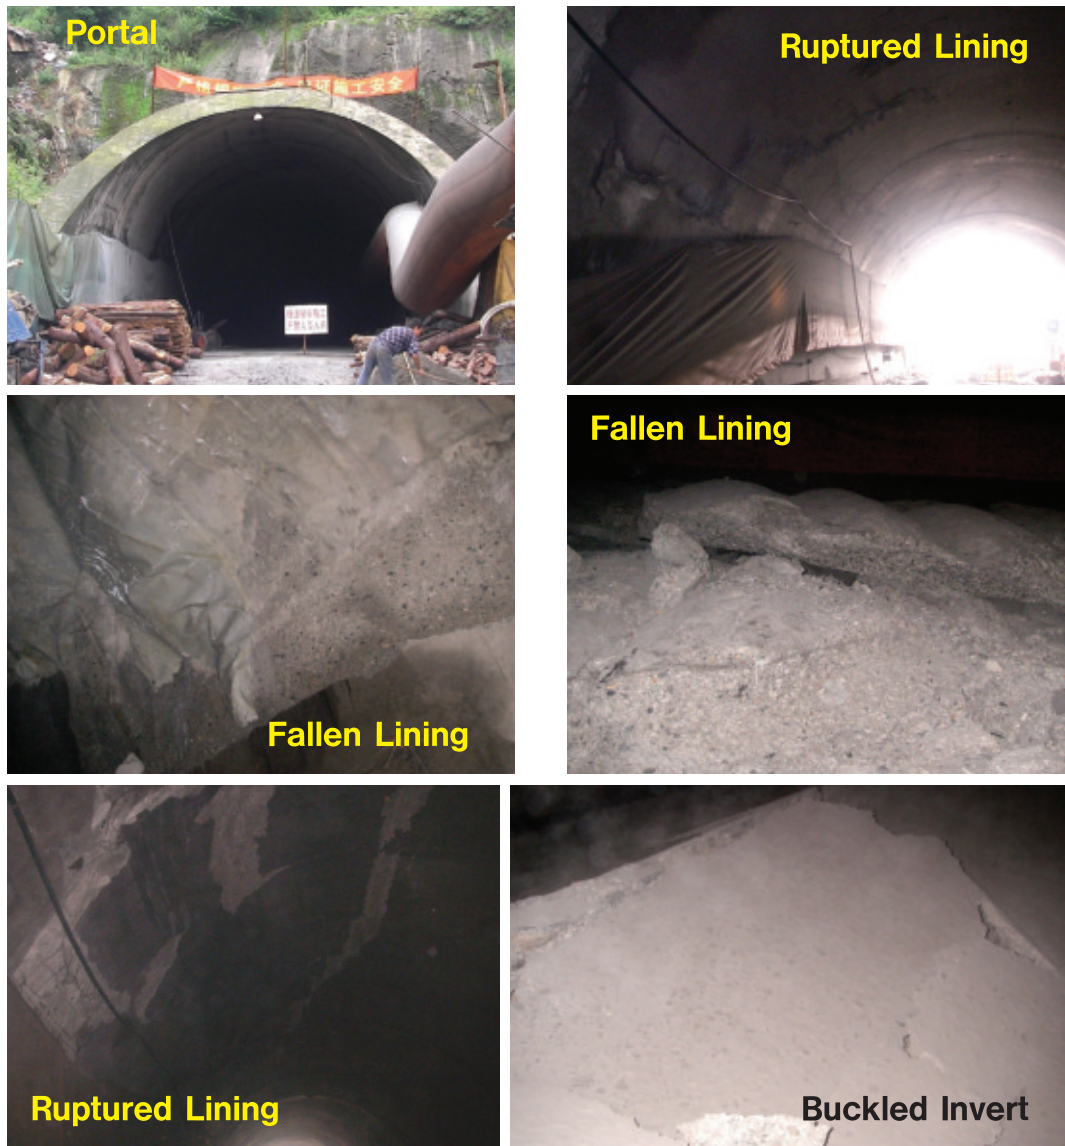
Longxi tunnel is a part of Wenchuan-Dujiangang expressway. Two double laned tunnels are excavated with a 3D wide pillar. The maximum overburden is about 480m and the maximum in-situ stress measured is about 26 MPa. The fault named as F8 is 900m from the SE portal and its strike is perpendicular to the longitudinal axis of the tunnel. The engineers informed the authors that they had difficulty of maintaining the stability and controlling the deformation of the tunnel during excavation, indicating that the tunnel experienced squeezing phenomenon.

concrete lining was constructed. The concrete lining was ruptured and the crown concrete was fallen down (Figure 23). However, the overall rupture trace dips NW. The floor of the tunnel was also ruptured and uplifted by buckling. The tunnel collapsed at the location where the overburden is about 70m. The collapse may have created a sinkhole at the ground surface, which should be checked. The similar type of the collapse occurred at the Elmalik section of Bolu Tunnel during the 1999 Duzce-Bolu earthquake (Aydan *et al.* 2000). The ground conditions at both tunnels were remarkably similar to each other. The engineers still did not checked the zone beyond the collapsed section of the tunnel. The fundamental causes of the damage to this tunnel is probably the permanent ground deformations along the fault zones as well as high ground shaking.

**Figure 23.** Views of earthquake damage at Longxi (Longqi) Tunnel

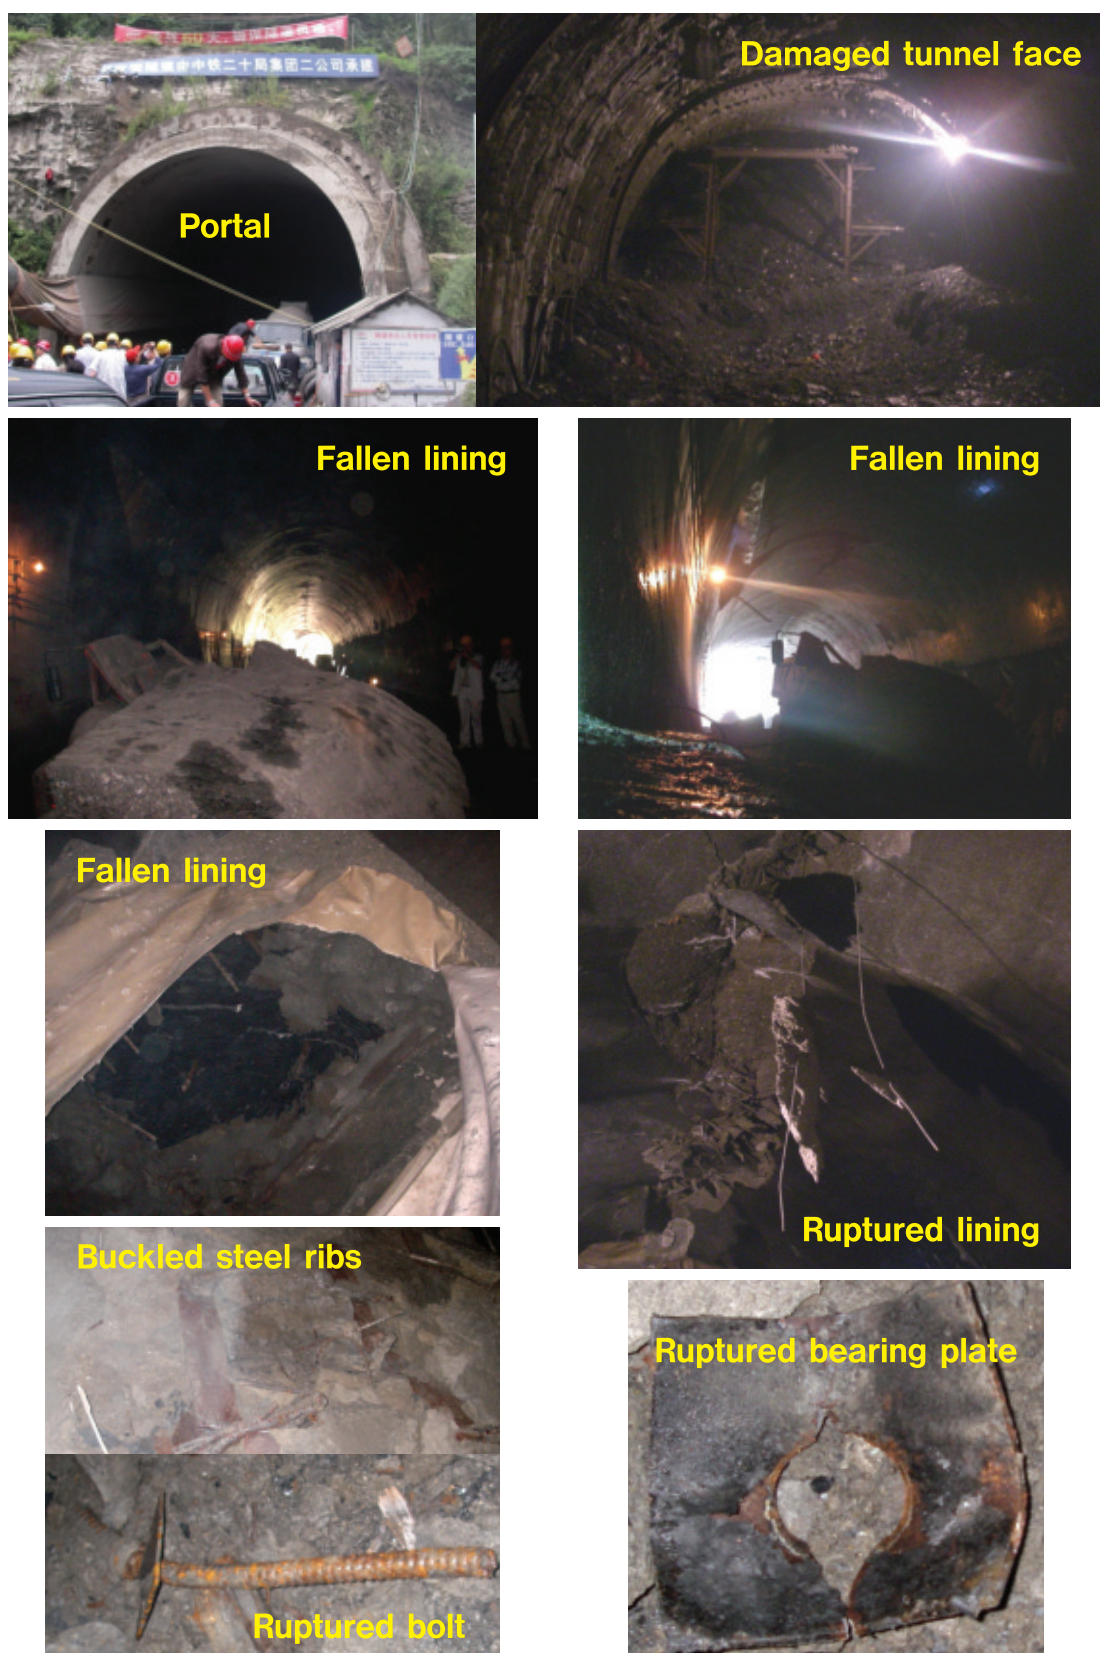
Jiujiaaya Tunnel is a 2282m long double lane tunnel and the coordinate of its south portal is N32.41288 and E105.12046. The tunnel is 226.6km away from the earthquake epicenter and it is about 3-5km away from the earthquake fault of the Wenchuan earthquake. The tunnel face was 983m from the south portal at the time of the earthquake (Figure 24). The concrete lining

follows the tunnel face at a distance of approximately 30m. The tunnel suffers from metan gas problem due to coal seams below the tunnel. The rock consists of phyllite with intercalations of dolomite. The bedding planes has the orientation of NW50/64, which is roughly similar to that of the Longmenshan fault zone. The geological investigation indicated that the tunnel pass through several fracture zones. The engineers informed the authors that 30 workers were working at the tunnel face and one worker was killed by the flying pieces of rockbolts, shotcrete and bearing plates caused by intense deformation of the tunnel face during the earthquake. The concrete lining was ruptured and fallen down at several section (Figure 24). However, the effect

of the unreinforced concrete lining rupturing was quite large and intense in the vicinity of the tunnel face. The rupturing of the concrete lining generally occurred at the crown sections although there was rupturing along the shoulders of the tunnel at several places. Furthermore, the invert was uplifted due to buckling at the middle sections. Sometimes, the whole invert was pushed upward. The authors noticed that the tunnel heading was offset in a dextral sense with an upward movement with respect to the rest of the tunnel. The lateral and vertical offset displacements are approximately 100mm. This sense of deformation is very similar to that of the Longmenshan fault zone, which probably cuts through the tunnel with an acute angle of 50–

60°. Besides the high ground shaking, the permanent ground deformations definitely played an important role on the damage observed in Jiujiaya Tunnel. Figure 25 illustrates a classification of damage to tunnel linings.

Figure 24. Views of damage at Jiujiaya Tunnel

manner, this may result in secondary disasters during their service life. Therefore, some counter-measures are necessary to deal this problem. There may be two possible ways to deal with this issue. The first alternative would be to line the concrete lining with thin steel platens together with rockbolts. The other alternative may be to use fiber reinforced polymers together with rockbolts to line the inner side of the conceret lining. These countermeasures should be introduced not only in China but also other countries.
