Characteristics of 2009 L'Aquila earthquake with an emphasis on earthquake prediction and geotechnical damage

Ömer AYDAN*¹, Halil KUMSAR*², Selçuk TOPRAK*³ and Giovanni BARLA*⁴

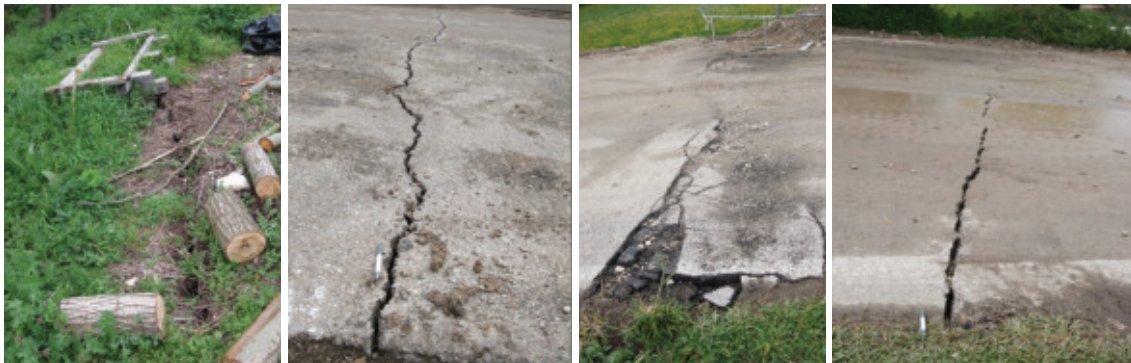
Horizontal movements and cracks were observed in the area of the Aterno River to the west of Onna. The embankments on both sides of the Aterno River moved towards the river creating separation cracks as well as some compression cracks in the vicinity of a damaged bridge as shown in Figure 17. The cracks in the east side of the river were more intensive as the ground was inclined towards west. Nevertheless, no sand boiling was observed.

Based on InSAR evaluation, ground movements are large in the close vicinity of Aterno River near Onna. Tectonic movements, ground liquefaction or both might have caused these movements. If ground liquefaction is involved, it is likely that there is a thick impermeable silty and clayey layer on top of the liquefiable ground below.

Figure 17. Views of cracking.

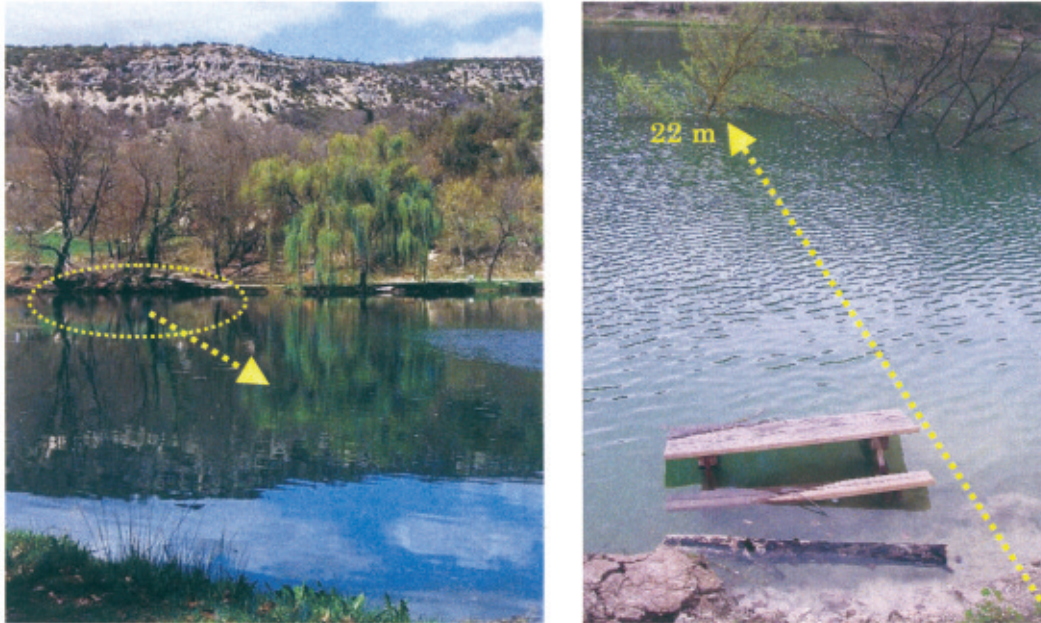
The mechanical properties of ground are not known for this site, yet. However, some preliminary analyses were carried out to evaluate the likely conditions involved with the ground failures, which were observed

Figure 19. Views of ground failure before and after the earthquake.

in detail. A series of trial and error computations were carried to obtain material properties, which yield the displacement values close to the measured values. The computational results are shown in Figures 20 and 21 by using the strong motion records of the AQG station. The estimated maximum ground acceleration from a toppled rock block on the north side of the lake was about 0.38g, which is very close to that measured at the station.

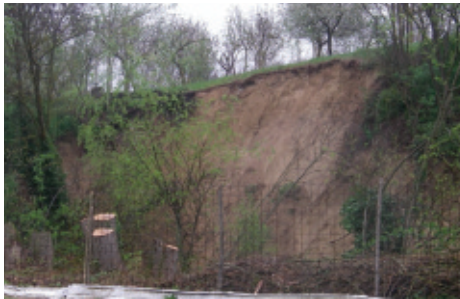
(a) Martini district

slope failures; b) Surficial slides of weathered rock slopes c) Rock slope failures (Planar sliding, Wedge sliding failure, and Flexural or Block toppling), and d) Rock falls. As the magnitude of the earthquake was small and the duration of shaking was short, the scale of slope failures was small. Nevertheless, rock falls induced damage to structures and roadways. Soil slope failures were also observed along the Aterno river shores, and in mountainous areas such as in the vicinity of Campotosto. Figure 22(a) shows a soil slope failure along the Aterno River in Martini District and Figure 22(b) illustrates a soil slope failure near Paganica.

Figure 22. Examples of soil slope failures.

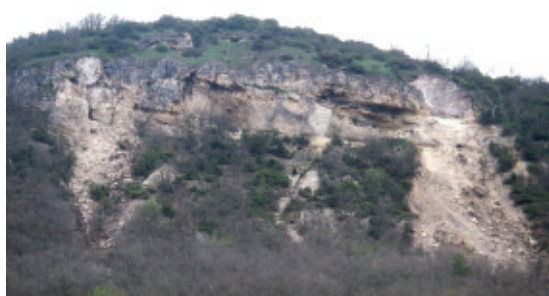
(a) Sinizzo

Failures of rock slopes were observed in the vicinity of lake Sinizzo (Figure 23(a)), of a quarry near Bazanno and Fossa, and roadway cut slopes (Figure 23(b)). Most of rock slope failures involve natural discontinuities such as faults, joints and bedding planes. Depending on the orientation of rock discontinuities, the slope failures may be classified as planar and/or wedge sliding failures, toppling or combined sliding and toppling failures.

Figure 23. Examples of rock slope failures.

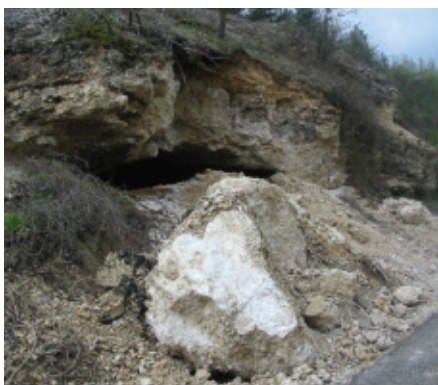
(a) San Demetrio ne' Vesti

Figure 25. Examples of rock falls.

As shown in Figure 25(a), overhanging slopes of conglomeratic deposits were fallen at San Demetrio ne' Vestini. The surfaces of the fallen blocks imply that they have failed in tension. The dynamic stability of these fallen overhanging slopes may be analysed by considering a flexural toppling mode (Aydan and Kawamoto 1987, 1992). The overhanging length of the fallen blocks due to flexural toppling failure was about 150 to 170 cm, while their thickness about 100 cm. Figure 27 shows the computational results for a tensile strength ranging between 180 and 200 kPa while the unit weight

of rock was assumed to be 20 kN/m³. Furthermore, the ratio of vertical to horizontal acceleration was assumed to be 0.85, with the consideration of measured maximum acceleration values. The matrix of conglomerate is calcareous and it is relatively weak. The estimation of the tensile strength of conglomerate at this site seems to be quite acceptable. In the same site, there are many overhanging conglomerate layers. The length of stable overhanging conglomerate layers observed is generally less than 100–120 cm. These observations are in accordance with the computational results.

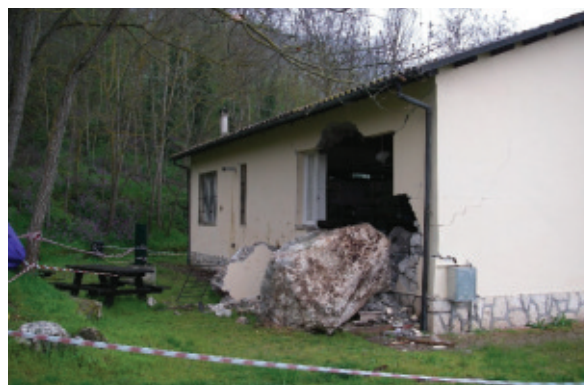
(b) Stiffe

Rock falls were observed in the areas where steep rock slopes and cliffs outcrop. Large scale rock falls were observed in the vicinity of Stiffe, San Demetrio ne' Vestini and lake Sinizzo and Paganica (Figure 25). Some of these rock falls induced damage to structures. It is well known that rock falls occur following failure initiation of individual rock blocks in sliding, toppling or combined sliding and toppling modes. Therefore, it is of interest to back analyse the initiation of the rock fall observed in the vicinity of Stiffe due to sliding motion. The size of fallen block of limestone was approximately $190 \times 150 \times 160 \text{ cm}^3$. The rock fall is initiated when relative sliding exceeds its half width. As the thickness of the block is about 160 cm, the possible half width range of the block should vary between 75 and 95 cm. The base

inclination of the block is taken as 20° in view of the limestone bedding inclination in the vicinity of Stiffe. Figure 26 shows the computational results for the record taken at the AQQ station under half saturated conditions, as there is no acceleration record in the vicinity of Stiffe. The static and kinetic friction angles of the interface between the base and block was taken as 35° and 30° in view of experimental results available to the authors for the bedding planes of Alpine limestone. Although it is essential to perform rock mechanics tests on the interface characteristics of the fallen rock block, the chosen values should be sufficient for this preliminary analysis. For the chosen values of interface properties, the computed relative displacement is 94.7 cm. If the shortest side of the block is selected, the block would definitely start to fall. If the other side is chosen, it would be at a limiting state. As the measured size of the block is approximate, the computed results should be sufficient to explain why the rock block fall occurred. A

toppling mode failure was not possible as the applied acceleration was less than 0.43 g.

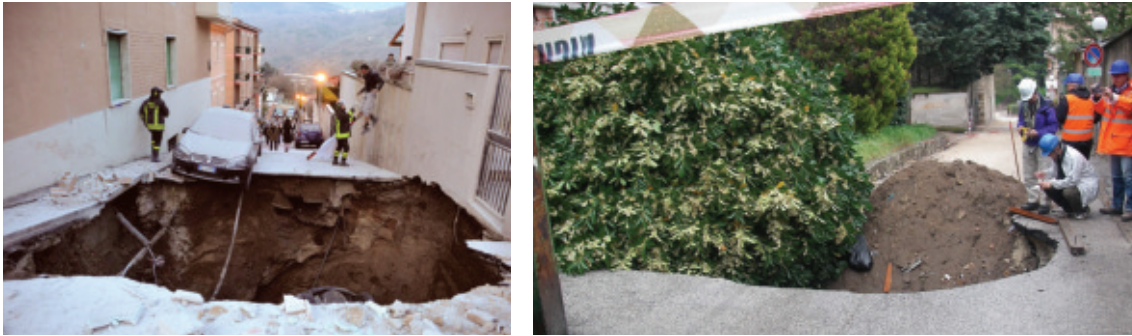
The L'Aquila earthquake caused a number of sinkholes in L'Aquila (Figure 29 and Table 3). One of the sinkholes was well publicized worldwide. The width was about 10 m and its depth is not well-known. A car was fallen into it. Another sinkhole had a slightly smaller size. Its length and width were about 8 m and 7 m, respectively. The depth was about 10 m. The layers between the roof and road level were breccia with calcareous cementation, breccia with clayey matrix and top soil from bottom to top. A side trench was excavated to a depth of 3 to 4 m from the ground surface on the

Figure 29. Sinkholes in L'Aquila.

strength of the roof material were assumed to be 20 kN/m³ and 560 kPa, respectively. The site observations indicated that a 300 cm deep trench was excavated on one side of the sinkhole site. Therefore, the trench excavations for sewage pipes drastically reduced the effective roof thickness. As expected, the increase of surcharge load drastically reduces the seismic resistance of roof of karstic caves.

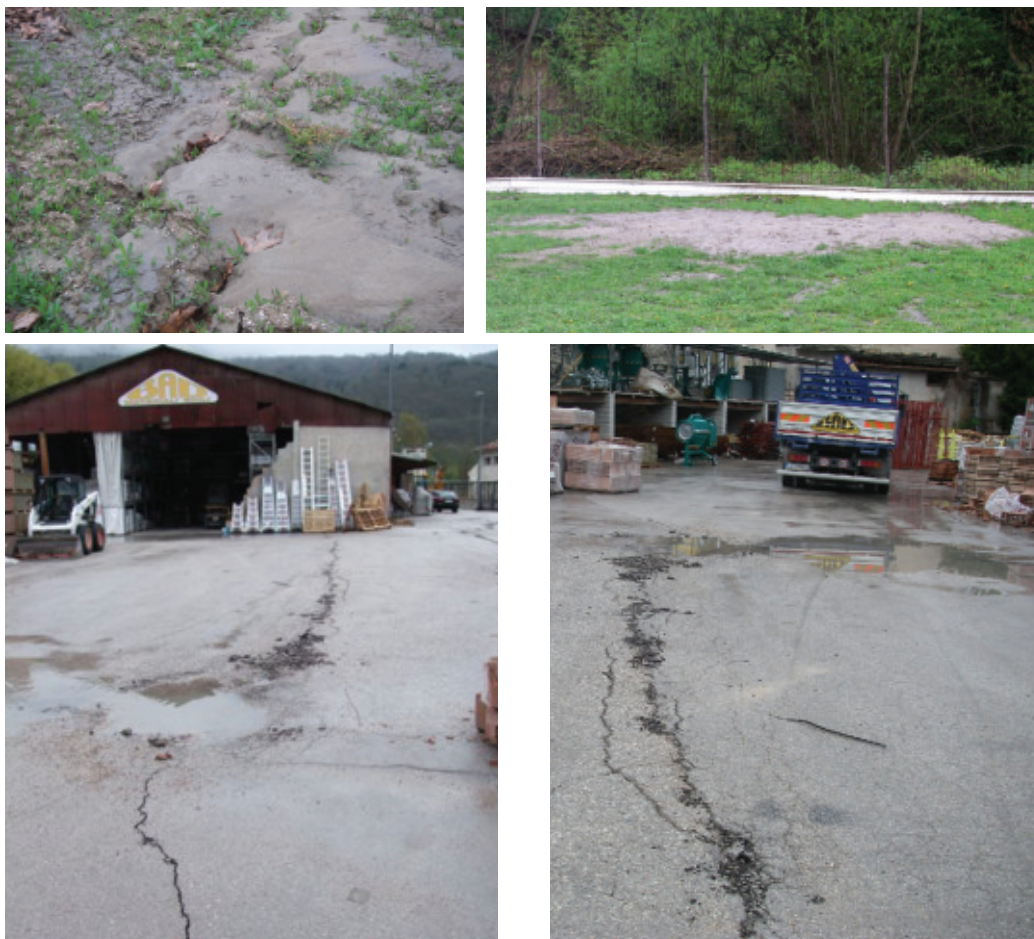
At Martini district liquefaction created many NE-SW trending fractures, parallel to the river embankment as shown in Figure 31. Sand boiling as thick as 150 mm was observed in various locations. The movement of ground was towards SE direction. Table 4 and Figure 32 show some physical properties and grain size distribu-

Figure 31. Ground liquefaction and lateral spreading induced damage and ground settlement at the depot yard in Martini district.

The liquefaction induced lateral spreading. The sum of crack openings from the adjacent field towards the river embankment ranged between 250 and 350 mm. There were several depot-like structures and bridges for railways and roadways in the area where soil liquefaction was observed. However there was no visible damage on the structures, probably because the foundations were resting on deep stiff soil.

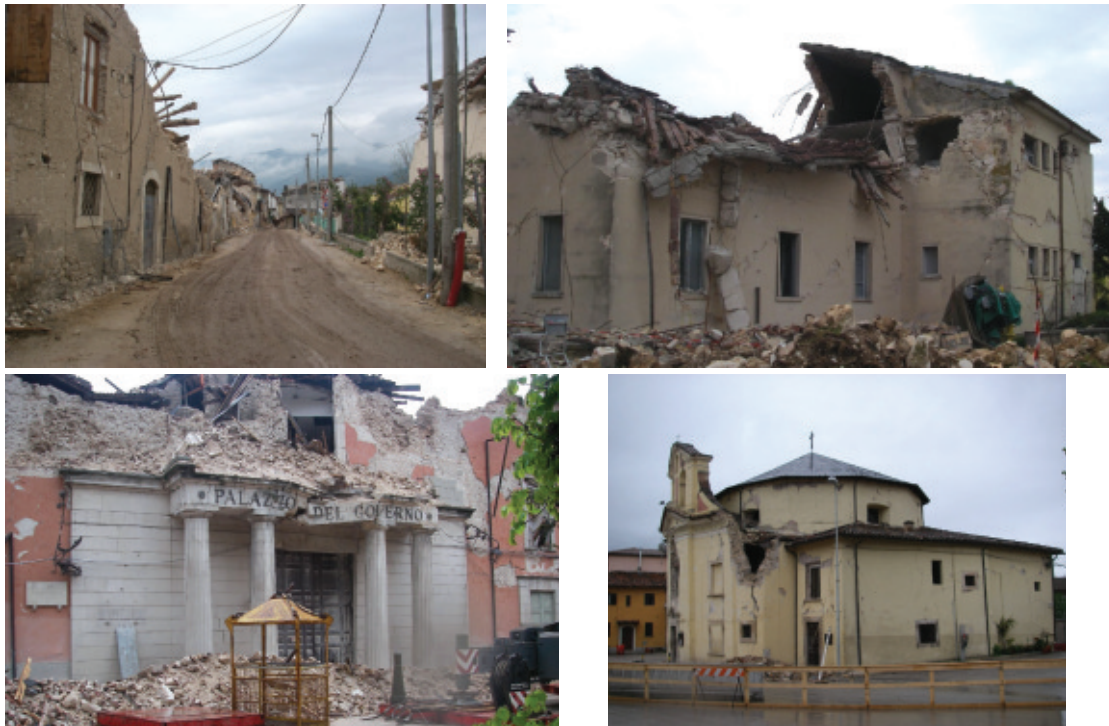
Masonry buildings can be grouped into residential buildings and cultural and historical buildings. (Figure 35). Residential masonry buildings are generally two story buildings made of stone, brick or mixture of stone and bricks. The mortar is mud or lime. Heavily damaged or collapsed buildings had almost no tie beams. Furthermore, the mortar of these buildings was mud. The main cause for the collapse or heavy damage of masonry buildings was out-of plane failure.

Figure 35. Examples of masonry building damage.

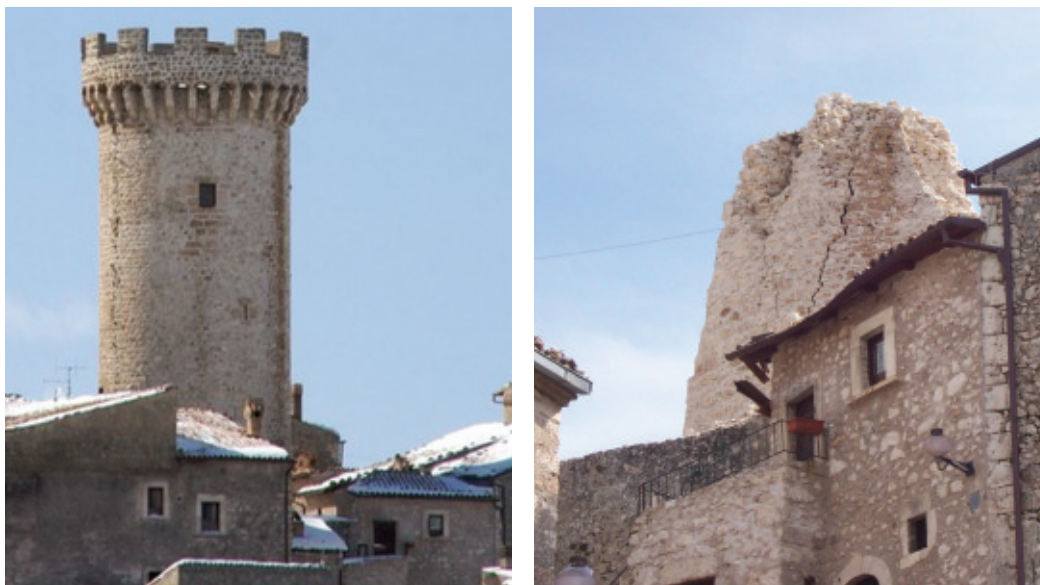
Cultural and historical buildings are of larger scale and involve, domes, towers and facades. The failure mechanism of these buildings is fundamentally quite similar to that of ordinary masonry buildings. The non-existence of tie beams makes these buildings quite vulnerable to heavy damage and collapse. The dome of Santa Maria del Suffragio collapsed although wooden tie beams were used. As the wooden tie beams were not continuous over the perimetry of the dome, its effect was disastrous. The masonry cylindrical tower at Santo Stefano di Sessanio, which is about 20km from the epicenter, was completely collapsed (Figure 36). It is

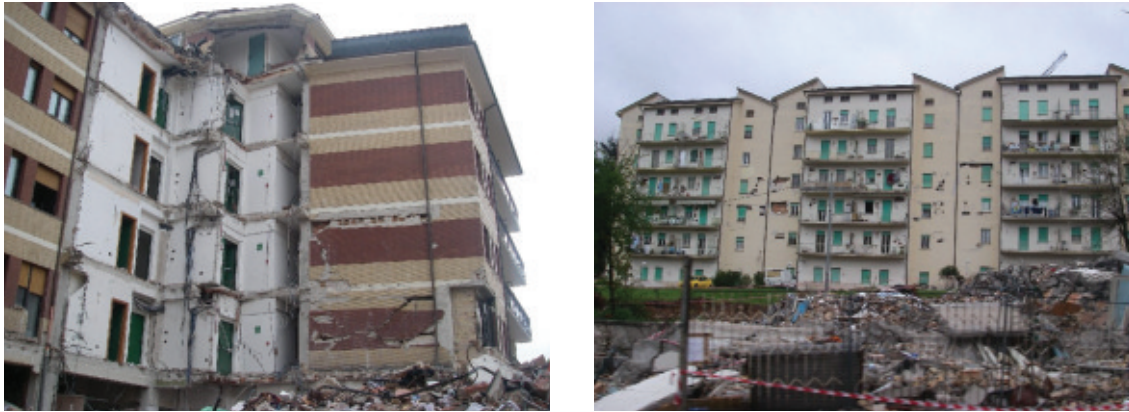
either collapsed and heavily damaged by the earthquake (Figure 37). The reasons of the heavy damage or collapse have similarity with those seen in Turkey and elsewhere. The possible reasons are poor workmanship, design and construction mistakes, resonance, lack of moral, weak (soft) floor effects and collision. It was even interesting to note in some of the heavily damaged buildings that

Figure 37. Examples of heavily damaged or collapsed reinforced concrete buildings.

the unwashed sea sand was used for concrete mixture, although L'Aquila is 90 km away from the sea.

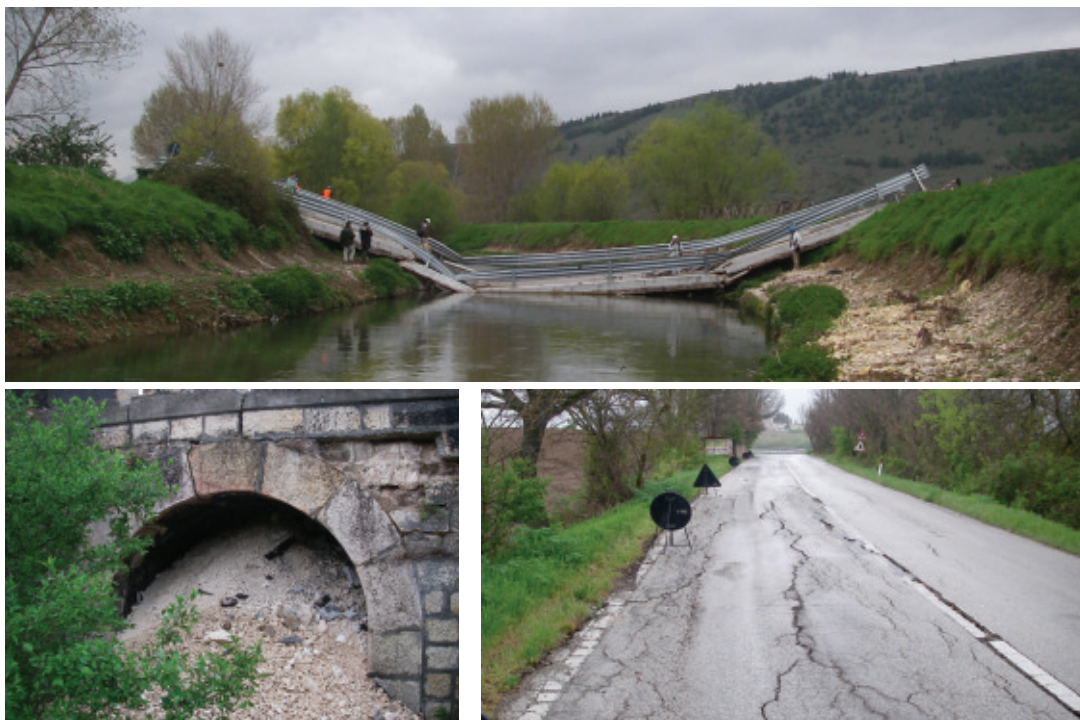
A 2 m long and 2.5 m high stone masonry arch bridge collapsed and was repaired by filling crushed limestone into the collapsed section as seen in Figure 38.

Figure 38. Collapse bridges and damaged road surfacing.

The southwest side abutments (Figure 38) were probably moved towards west and this movement resulted in the loss of arching effect, and collapse during the earthquake. Furthermore, the infill cover of this bridge was thin. This may be also an additional cause for the collapse.

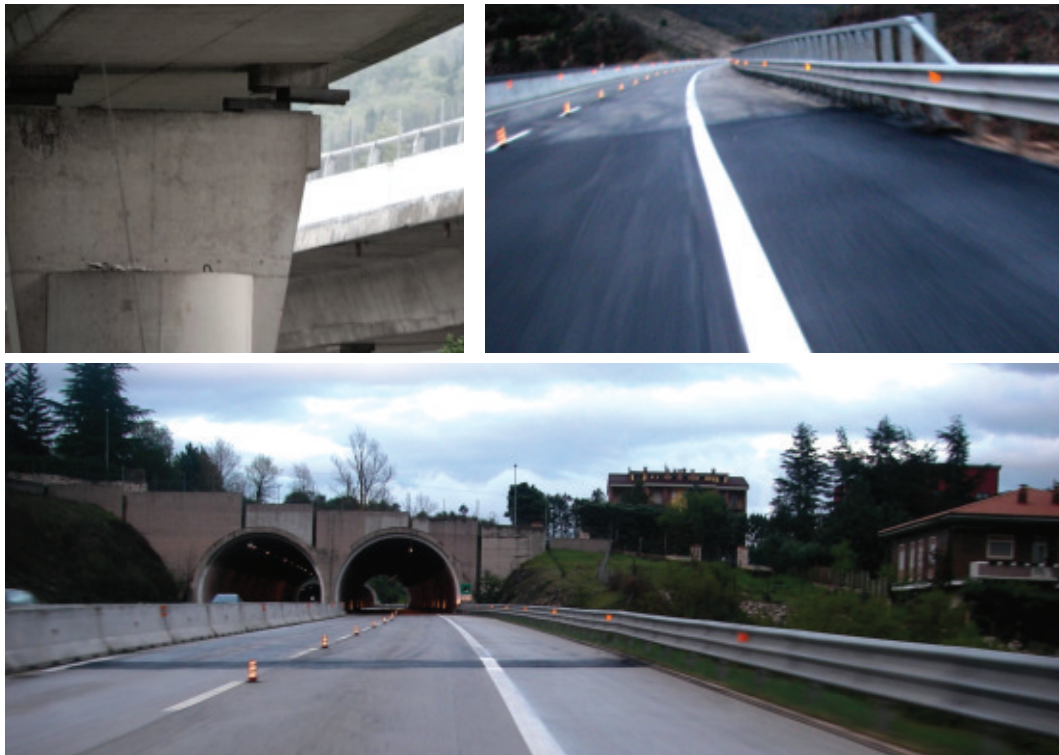
Figure 39. Damage to A24 expressway.

transverse directions. Some of these gaps were repaired by asphalt filling.

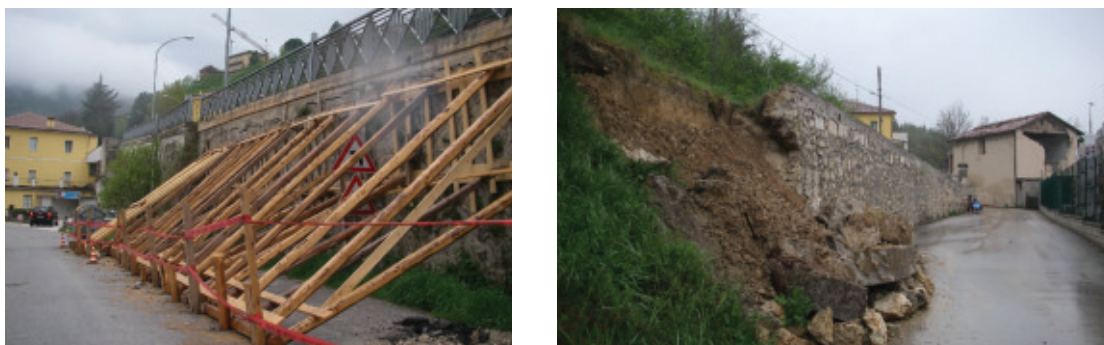
Figure 40. Examples of damage to masonry retaining walls.

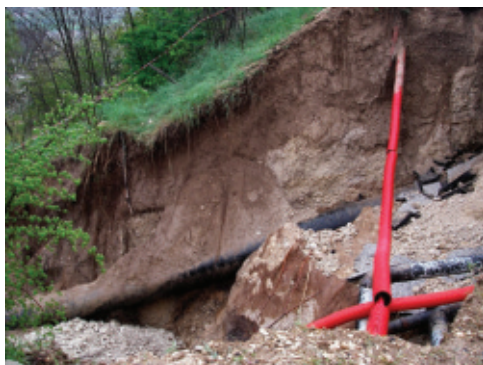
(a) Paganica

permanent ground deformation, which may result from faulting, slope failure, liquefaction induced lateral spreading. The authors observed damage to water pipes in Paganica and near Onna. (Figure 41). The damage to water pipelines in Paganica was caused by the combined effect of faulting as well as slope failure. Pipes failed due to by the extensional movement of the surrounding medium. The damage to the pipe near Onna was caused by the movement of the surrounding ground towards the center of the bridge over the Aterno River. The pipes were damaged at both sides of the river. Nevertheless, the movement was much larger on the eastern side of the bridge and the pipe was buckled.

Figure 41. Damaged pipes by permanent ground movement.

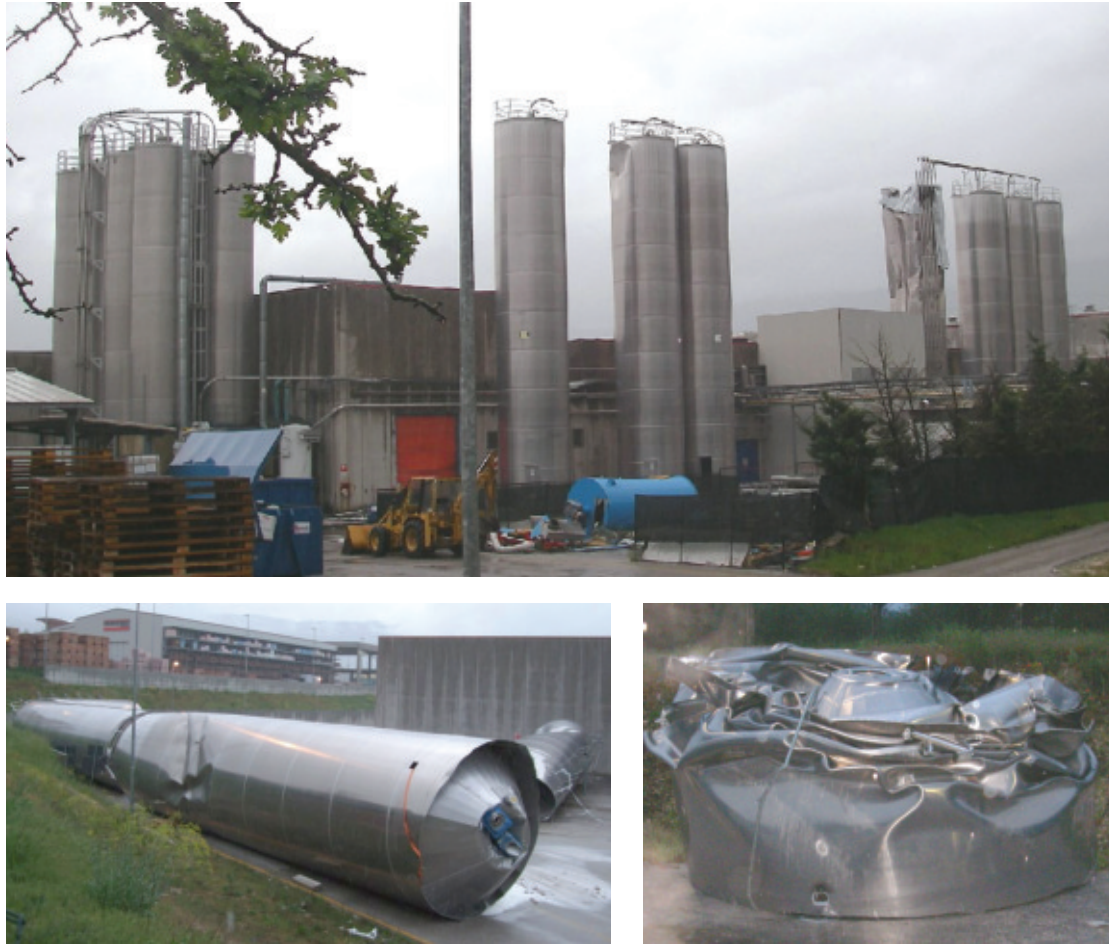
Figure 42. Views of buckled silos.
