# Geological and Seismological Aspects of Kashmir Earthquake of October 8, 2005 and A Geotechnical Evaluation of Induced Failures of Natural and Cut Slopes

Ömer AYDAN\*<sup>1</sup>

**Keywords:** Kashmir, earthquake, Muzaffarabad, thrust fault, slope failure

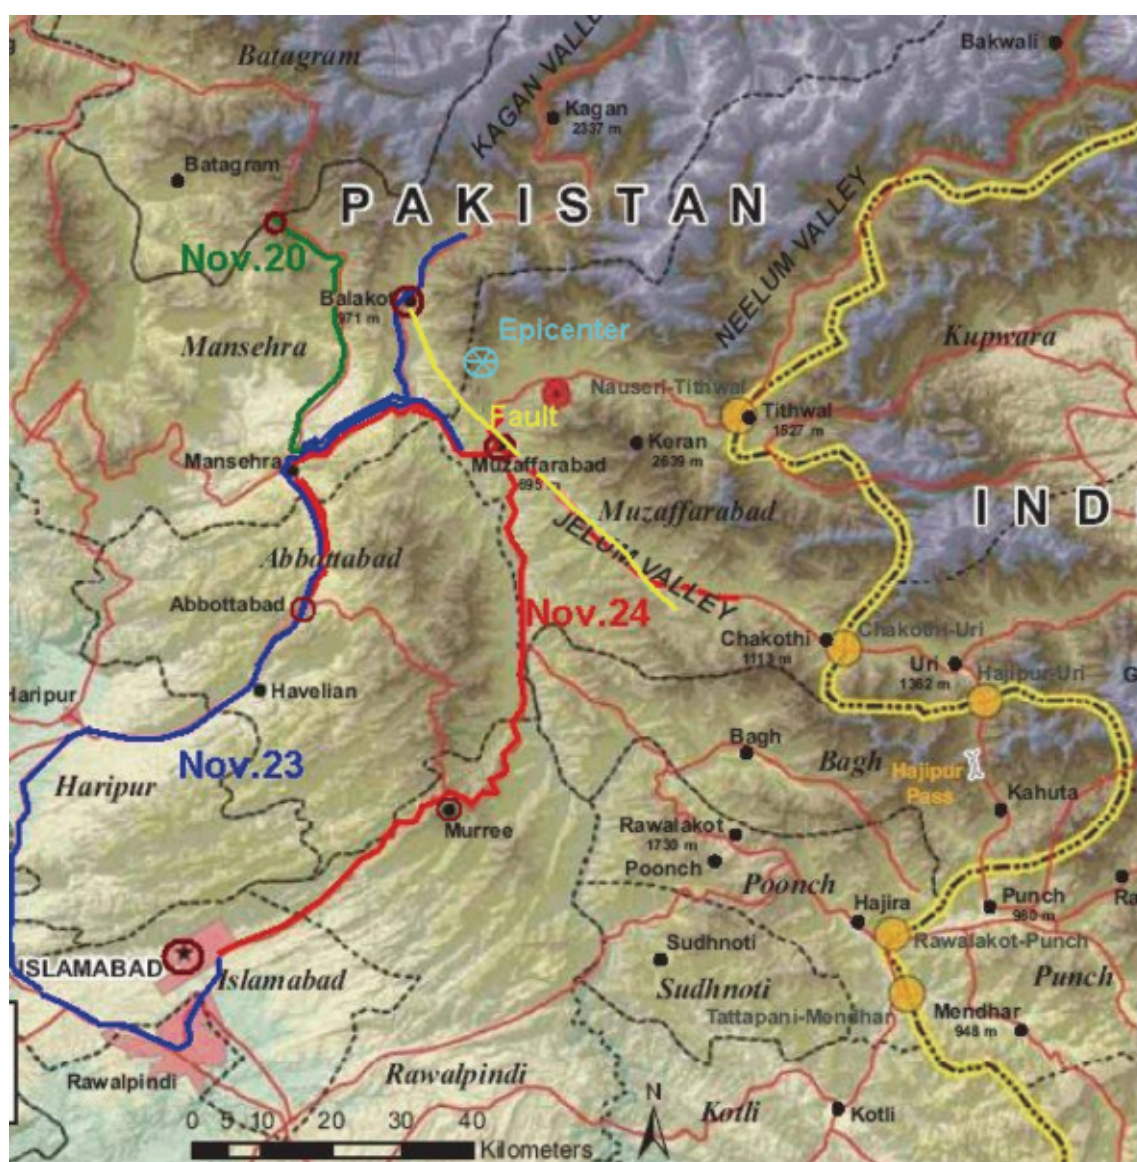
Figure 1. Routes of investigations

JSCE and AIJ jointly dispatched an investigation/technical support team to Pakistan from the 18th to 28th of November, 2005 (Figure 1). The author was one of the members of the joint team of JSCE and AIJ. The author also had the second chance to visit the damaged area as a member of the team dispatched by JICA during January 17-23, 2006. In the first part of this article, an overall view of the geological and seismological aspects of the Kashmir earthquake of October 8, 2005 is described. Then the characteristics of the failure of natural and cut slopes induced by the earthquake are presented and their implications on civil infra structures and site selection for reconstruction and rehabilitation are presented.

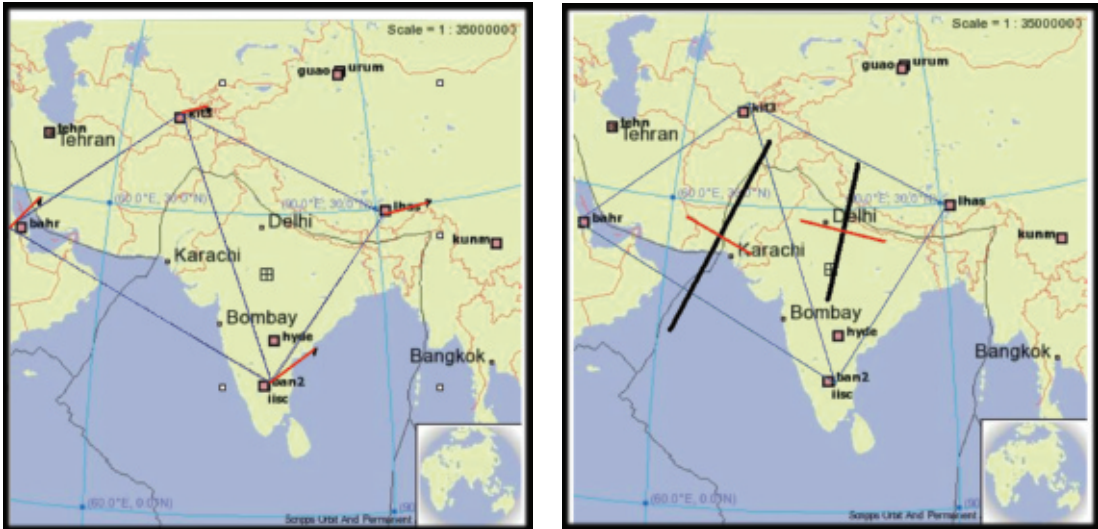
Crustal deformation measurements have been carried out to observe the motions of crustal plates by International GPS service. Although some local GPS networks seem to exist in both Pakistan and India, the measurements are intermittent. Therefore, it is presently difficult to know the variations of local strains and stresses in the vicinity of the earthquake area. A rough estimation of the crustal straining in the vicinity in Pakistan and India is carried out using the measured annual deformation rates of GPS stations, namely, BAHR (Bahreyn), IISC (India), KIT3 (Uzbekistan) and LHAS (Tibet). The deformation rates at these stations are given in Table 1 and computed strain rates given in Table 2. The illustrations of annual deformation rates and strains are shown in Figure 6. As noted from the computational results, Indian plate in Pakistan undergoing much higher straining as compared with that in India.

Figure 6. Crustal deformation rates and strain rates in the vicinity of Pakistan

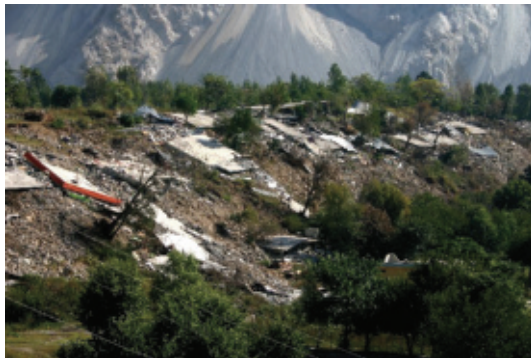
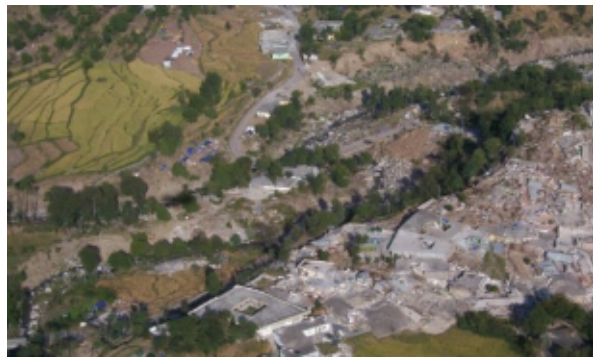
Soil slopes failures occurred in either plane sliding mode or circular sliding. Planar sliding modes are generally observed on soil slopes over the bedrock. Deep-seated circular type soil slope failures observed when the soil thickness was large. Some peculiar soil slope failures were observed in both Balakot and Muzaffarabad (Figure 13). These slope failures occurred in conglomeratic soil deposits with rounded large cobbles, which are products of the past glaciation's period (Figure 14). Since the slope angles were quite steep (60–80°), these slopes failed on surfaces involving partly vertical tensile cracks and curved shear plane. The residual slope angles (repose angle) ranges between 40–45°, which may be considered to be equivalent to its friction angles (Figure 15). Some needle penetration tests were carried out at both Balakot and Muzaffar-

(a) Slope failure nearby Muzaffarabad

(b) Slope failure in Balakot

**Figure 13.** Soil slope failures nearby Muzaffarabad and at Balakot. (Note that the slope failure nearby Muzaffarabad misinterpreted by some geologists as a folding structure resulting from thrust faulting)

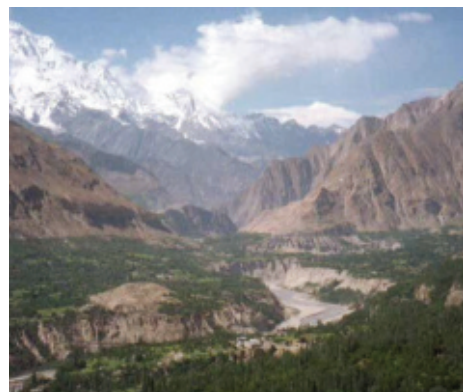
**Figure 14.** Illustration of steep soil slope formation and an example from Kashmir

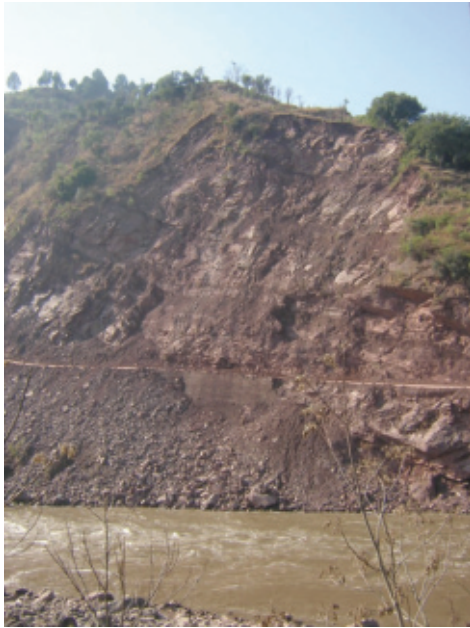
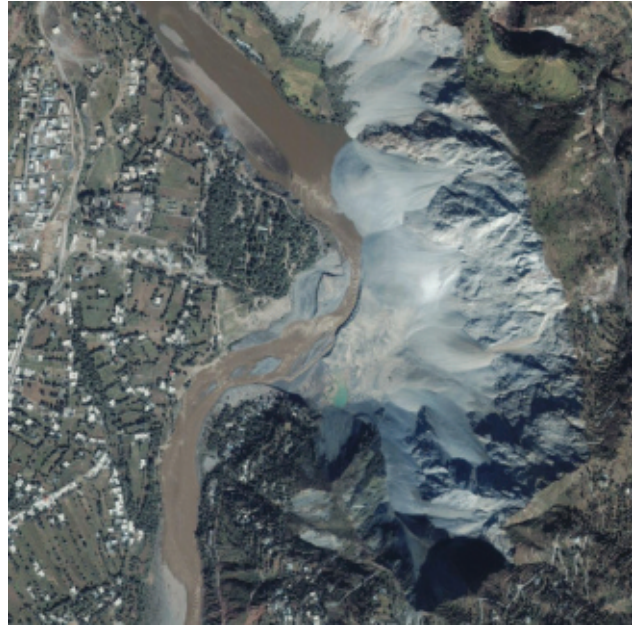
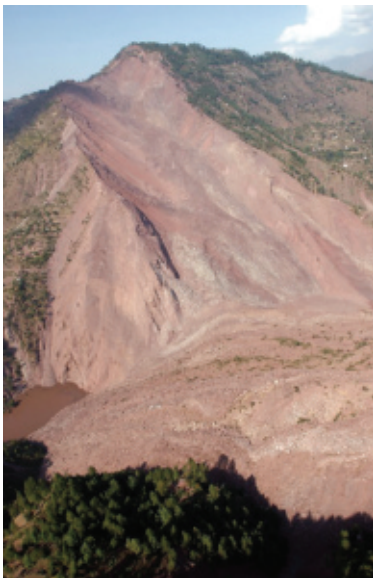
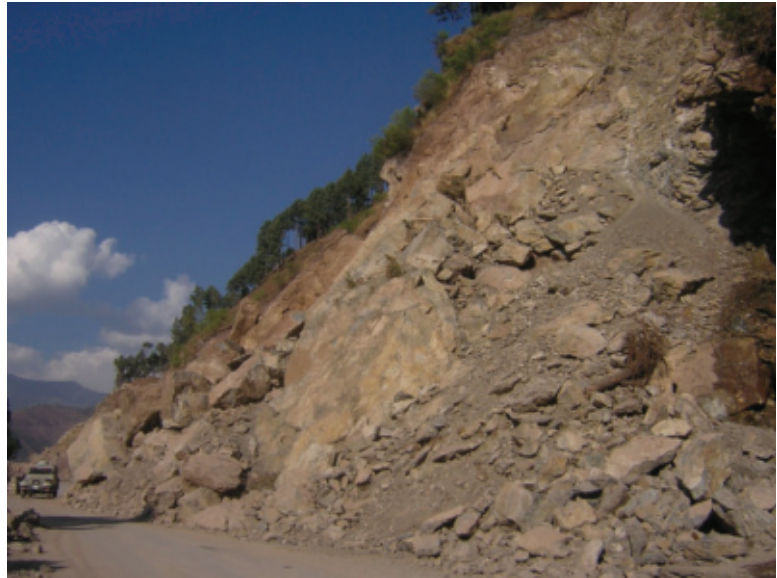
Rock falls in the epicentral area generally resulted from the toppling of rock blocks due to excitation of the earthquake. Numerous rock falls were observed for a great length of roadways. Rock falls were particularly common in sandstone slopes. Some flexural slope failures were also observed in intercalated sandstone and shale formation with undercutting. The satellite images indicated that there was a large-scale slope failure nearby Hattian in the vicinity of the SE tip of the causative fault. The slope failure was at Hattian (Dana Hill) and it is an asymmetric wedge sliding type. The estimated wedge angle is about 100°.

(a) Flexural toppling failure

(b) Surficial failure of fractured dolomite

(c) Wedge sliding failure

(d) Planar sliding failure

**Figure 16.** Views of some rock slope failures

Rock units in the epicentral area are schists, sandstone, shale, dolomitic limestone. Particularly red shale of Balakot formation is prone to weathering and the thickness of the weathered rock seems to be about 2–5 m. Dolomitic limestone rock unit is intensively sheared and this unit is thought to constitute the fault fracture zone. The surficial slope failures in dolomitic rock unit were spectacular and continued for several kilometers as they are clearly noticed in satellite images (Figure 8 and Figure 16(b)).
