# The Characteristics of M8.7 Nias Earthquake of March 28, 2005 and Induced Tsunami and Structural Damages

Ömer AYDAN<sup>\*1</sup>, Shigeru MIWA<sup>\*2</sup>, Hiroyuki KODAMA<sup>\*2</sup> and Tomoji SUZUKI<sup>\*3</sup>

## Abstract

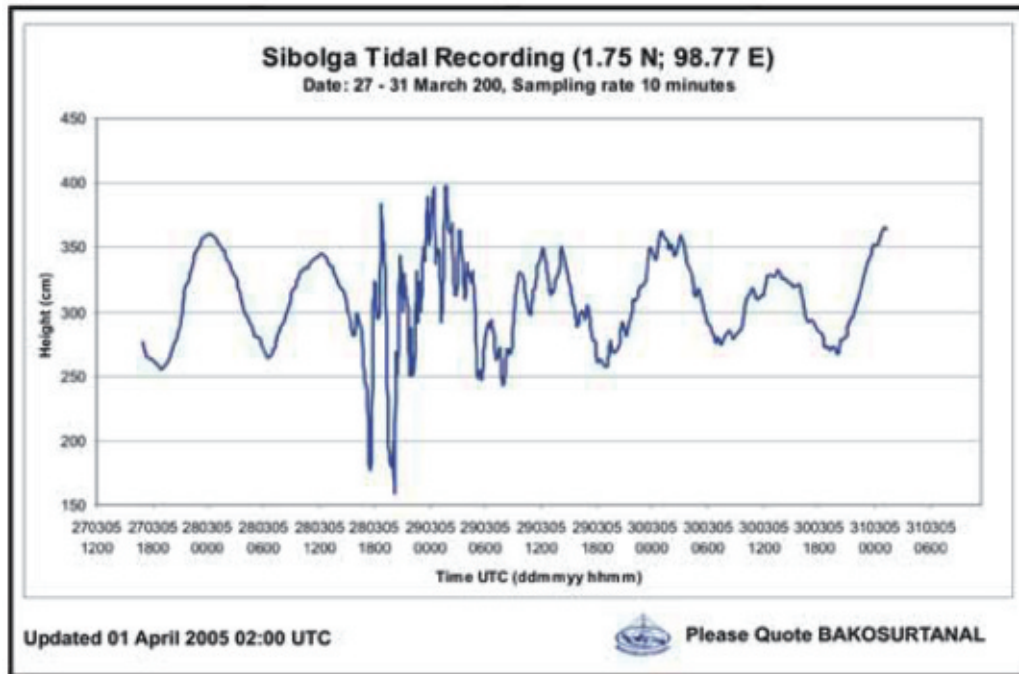
Figure 6 Tide gauge record at Sibolga station (from BAKOSURTANAL)

Indonesian Meteorological Agency has some tide gauges along the west coast of Sumatra Island. The highest wave was recorded at Sibolga tide gauge and it was more than 1m (Figure 6). The effects of tsunami were observed at Telukdalam and Thuemberua districts (Figure 7). The tsunami height could be about 4–5m in Thuemberua district while this value was less than 2m in Telukdalam district. A 2-metre wave struck the village of Sirombu on the west coast of Nias. Singkil residents have also reported that tsunami hit the coastal area and it was up to 4 meters high. Flooding up to a meter was also reported from as far north as Meulaboh.

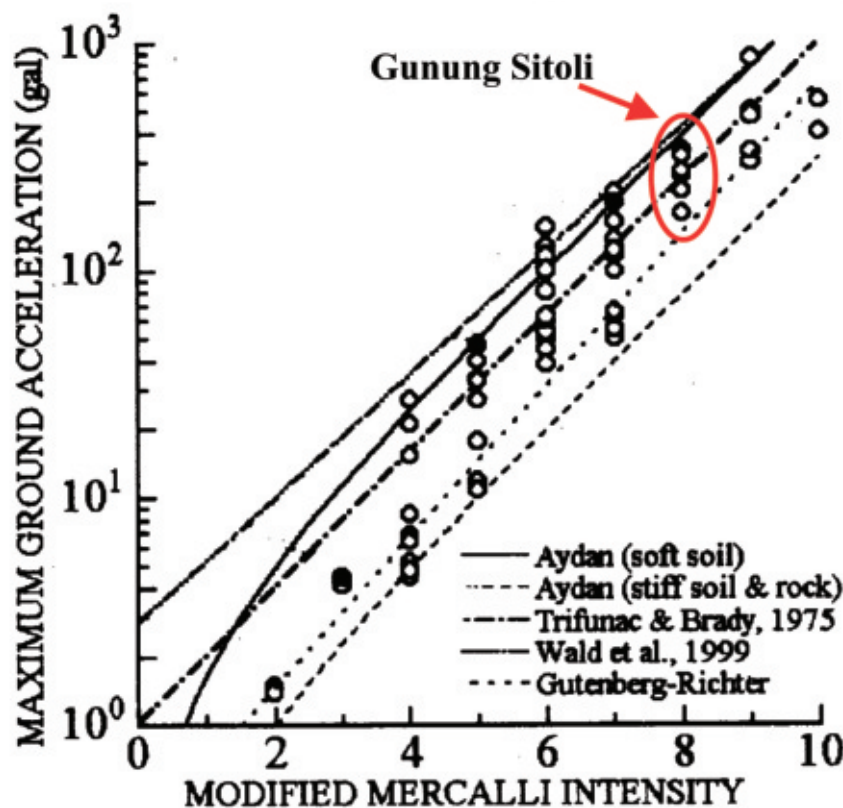
Figure 8 Inferred maximum ground acceleration ( $A_{max}$ )

coast of Sumatra Island. Therefore, it is almost impossible to know the exact ground motions during this earthquake. The only way is to infer the strong motions from the collapsed or heavily damaged structures such as reinforced concrete buildings, masonry or wooden houses and walls. The authors inferred the MKS intensity as IX from the observations of the collapsed buildings. Furthermore, the maximum ground accelerations should be ranging between 300 and 900 gals depending upon ground conditions using the approach proposed by Aydan (2002) (Figure 8).
