# The Characteristics of the 2008 Wenchuan Earthquake Disaster with a Special Emphasis on Rock Slope Failures, Quake Lakes and Damage to Tunnels

Ömer AYDAN<sup>\*1</sup>, Yoshimi OHTA<sup>\*2</sup>, Masanori HAMADA<sup>\*3</sup>,  
Jun ITOH<sup>\*4</sup> and Katsumi OHKUBO<sup>\*5</sup>

## Abstract

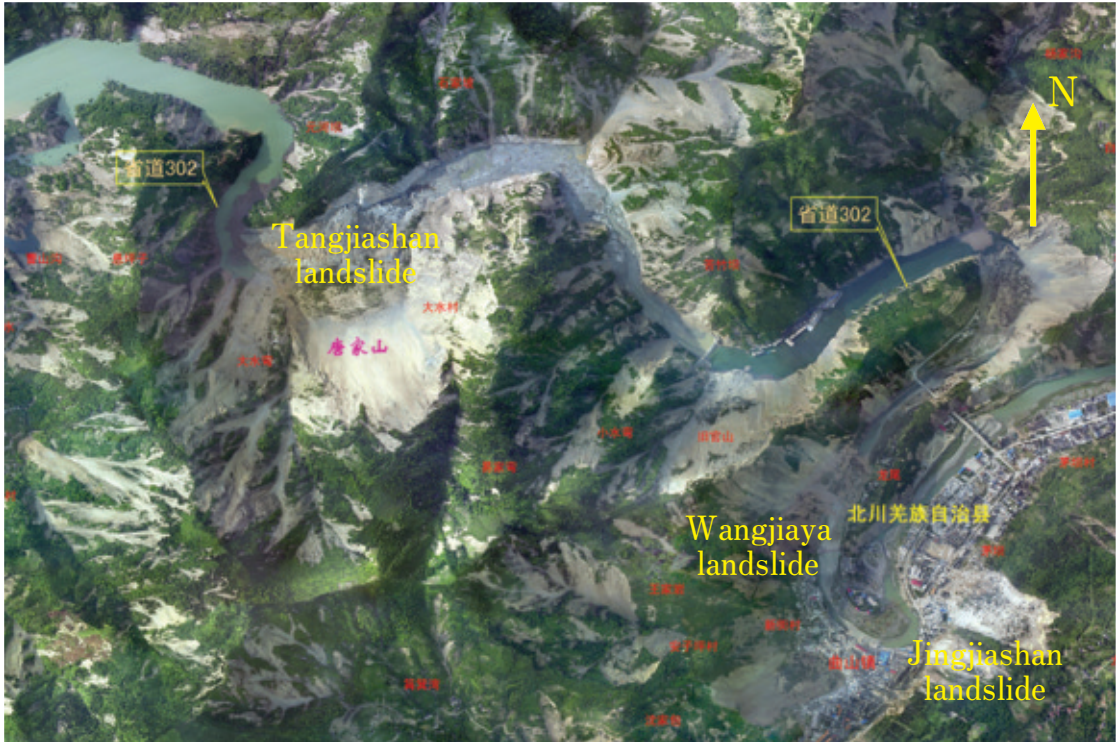
Figure 9. A satellite view of Beichuan and its close vicinity (modified from CGSI)

There are several large landslides in Beichuan town and its close vicinity including the Tangjiashan landslide (Figure 9). UNOSAT (2008) recently released a topographic map of the area (unfortunately such topographic maps are generally inaccessible in China) and a part of this topographic map is shown in Figure 10. In association with the sliding motion of the earthquake fault, NW and SE facing slopes failed during this earthquake. There were two large scale slope failures (landslides) in Beichuan county, which destroyed numerous buildings and facilities. The NW facing landslide (Jingjiashan) involved mainly limestone while the SE facing landslide (Wangjiaya) involved phyllite (it is mudstone and sandstone according to some) rock unit, which is folded with the anticline axis plunging NE (Figure 11). Limestone layers dips towards the valley side with an inclination of about 30°. Furthermore, there are several faults dipping parallel to the failure surface within the rock mass. The angles of the lower and upper parts of

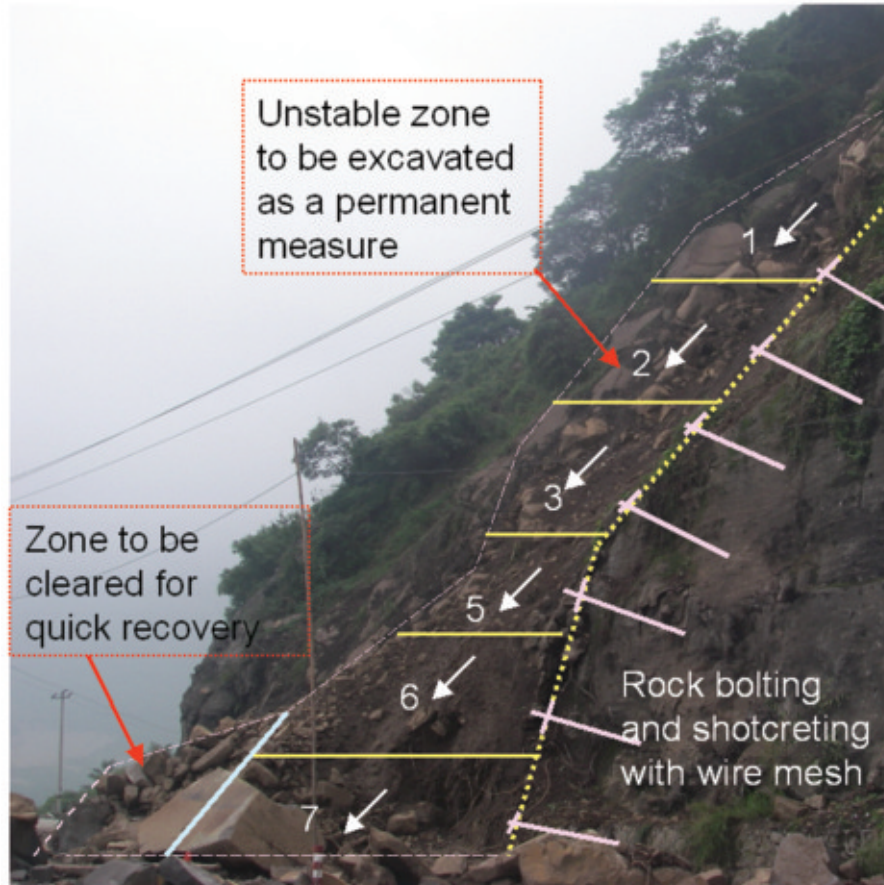
**Figure 14.** Proposed quick recovery and permanent measures for the restoration of failed slopes (Hamada and Aydan, 2008)

The mitigation measures against huge slope failures and rockfalls must be based upon the knowledge and know-how of modern rock slope engineering. Most of roadways were obstructed by the slope failures in the epicentral area. The debris of failed slopes should be cleared from top to bottom. Following the clearance of the failed part, an utmost care should be taken against the stabilization or clearance of the loose part. If possible, rockbolts, rockanchors with wire meshes and shotcrete could be utilized (Figure 14). However, it should be noted the shotcrete has no structural support effect except preventing the small scale falls and erosion. Furthermore, the slope failures were analyzed together with some computational results from previous studies by the first author. The results are shown in Figure 15 and this figure was prepared as a guideline for local engineers how to select the slope-cutting angle in actual restoration of the failed slopes.

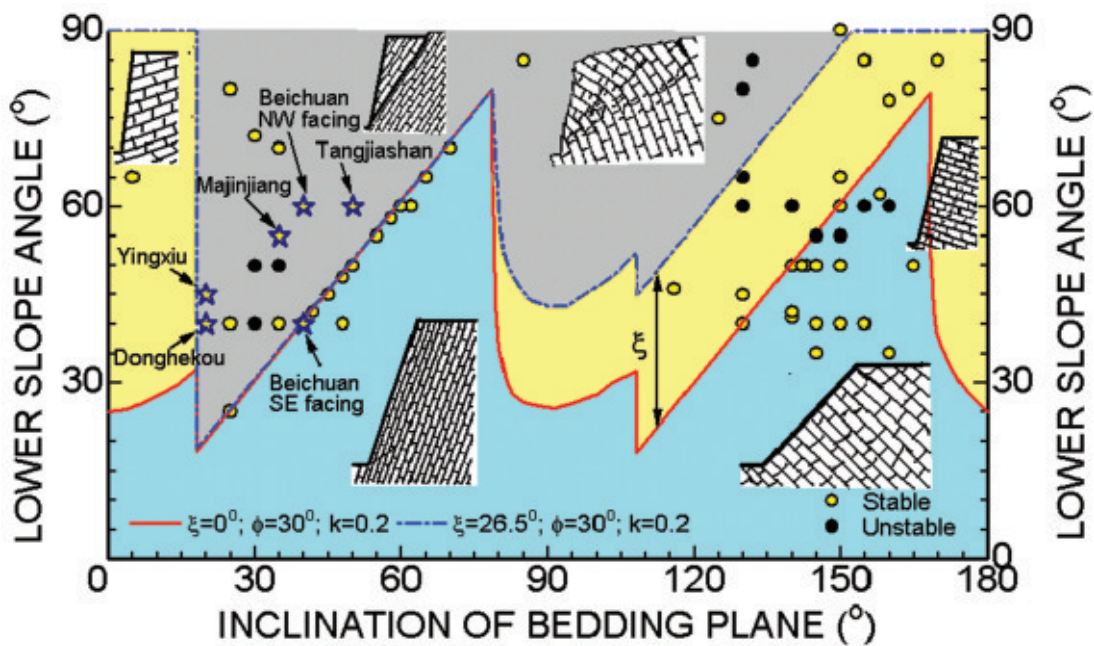
**Figure 15.** Proposed guideline for slope-cutting angle in relation to the bedding plane angle for the restoration of the failed slopes ( $\xi$ : intermittency angle;  $k$ : horizontal seismic coefficient;  $\phi$ : friction angle).

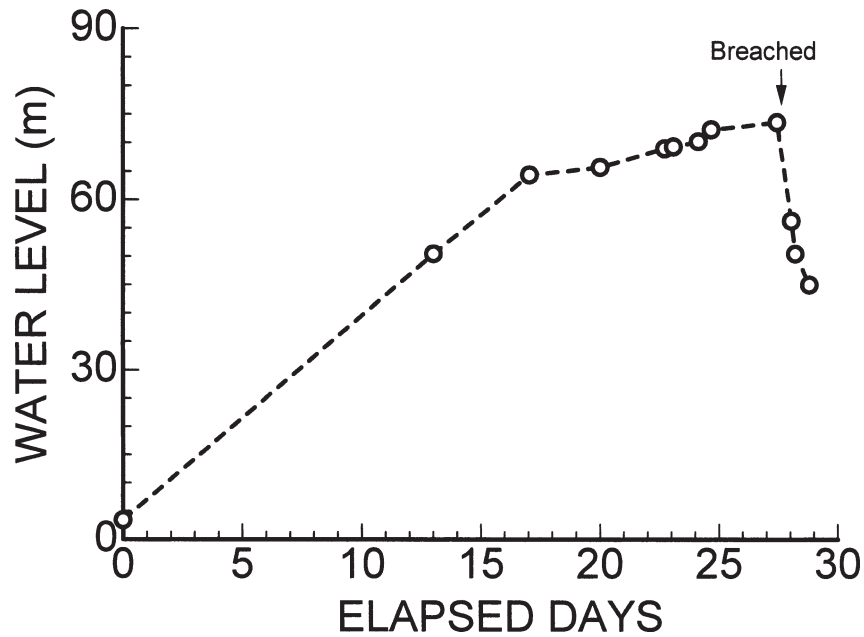
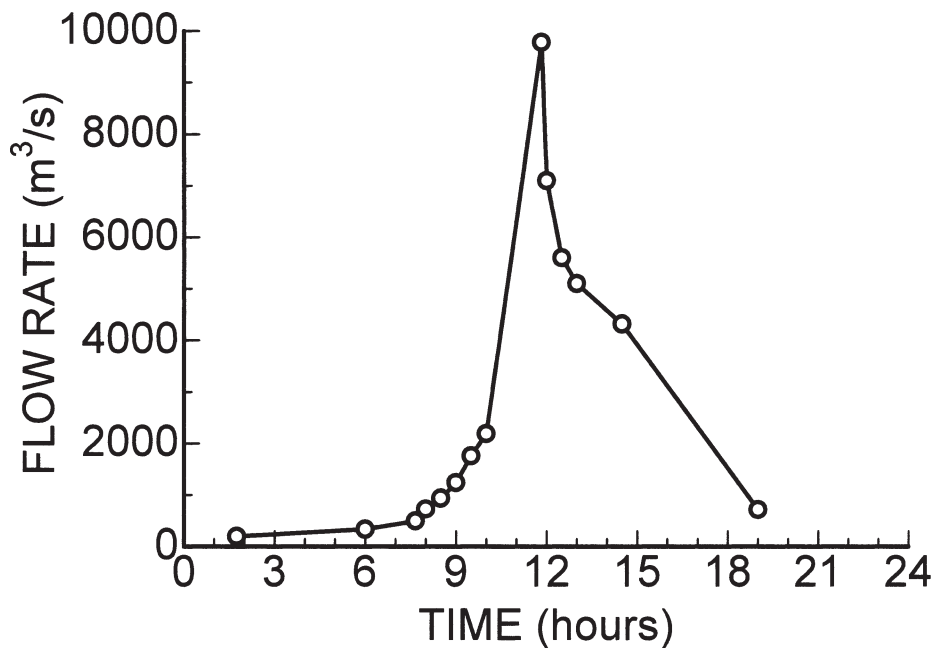
Among 34 quake-lakes, three quake-lakes formed in Anxian, Qingchuan and Beichuan counties, were of great scale and were caused by mainly the planar sliding failure of mountains. Among all, the biggest quake-lake was the Tangjiashan “quake lake”, which was formed by the collapse of a section of Tangjiashan Mountain. Tangjiashan quake-lake was formed 2 km from Beichuan and at its peak was 803m long by 612m wide and 70-124m high. The estimated volume of water of the Tangjiashan quakelake was 250M m<sup>3</sup>. Initially several spillways were constructed. However, the drainage through constructed spillways was not successful and several leakages occurred. At the final stage, explosives were used to create channels. However, these measures were not sufficient and missiles were used to control the drainage and erosion of the flow path (Figure 18, pictures by Xinhuanet (2008)). This dangerous operation resulted in a successful drainage of the Tangjiashan quake-lake almost one-month elapsed after the earthquake and a peak discharge of 980 m<sup>3</sup>/s was observed at 11:50 on June 10. Some 250,000 people downstream had already been evacuated during the drainage on June 10, 2008. Figure 19 shows the water level rise between May 12 and June 10 and drainage flow rate on June 10.

(a) Water level rise versus elapsed day

(b) Discharge rate in June 10 during which the landslide dam was breached

**Figure 19.** The water level rise between May 12 and June 10 and drainage flow rate on June 10 (data from China Water Resources)

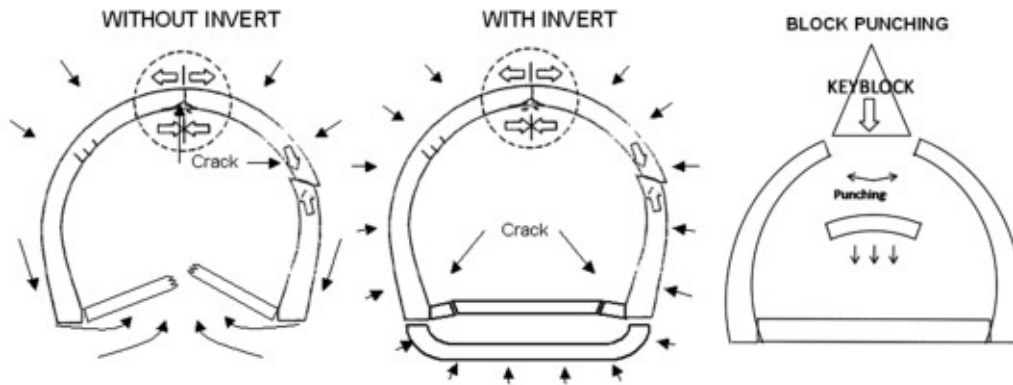
60°. Besides the high ground shaking, the permanent ground deformations definitely played an important role on the damage observed in Jiujiaya Tunnel. Figure 25 illustrates a classification of damage to tunnel linings.

Figure 25. Classification of damage to tunnel linings
