Characteristics of 2009 L'Aquila earthquake with an emphasis on earthquake prediction and geotechnical damage

Ömer AYDAN*¹, Halil KUMSAR*², Selçuk TOPRAK*³ and Giovanni BARLA*⁴

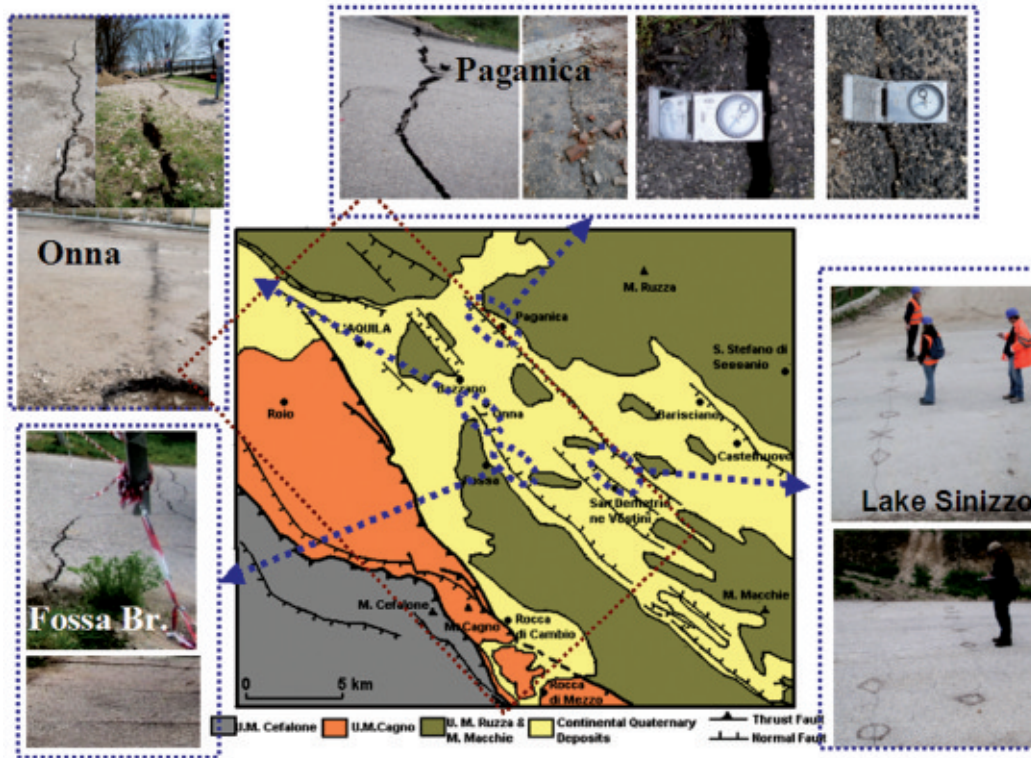
Surface ruptures were observed during the reconnaissance mission at Paganica, Lake Sinizzo, Onna and Fossa Bridge (Figure 7). Surface ruptures were observed at three locations in Paganica town. Most of the fractures at Paganica indicated the opening of surface cracks with a normal displacement.

Cracks were also observed on the road to Lake Sinizzo, which is thought to be the southeast end of the earthquake fault. There were also surface cracks in the vicinity of damaged or collapsed bridges on the Aterno River near Onna and Fossa towns. Some of the cracks were of compressive type while most of them were of

Figure 7. Locations and pictures of surface ruptures.

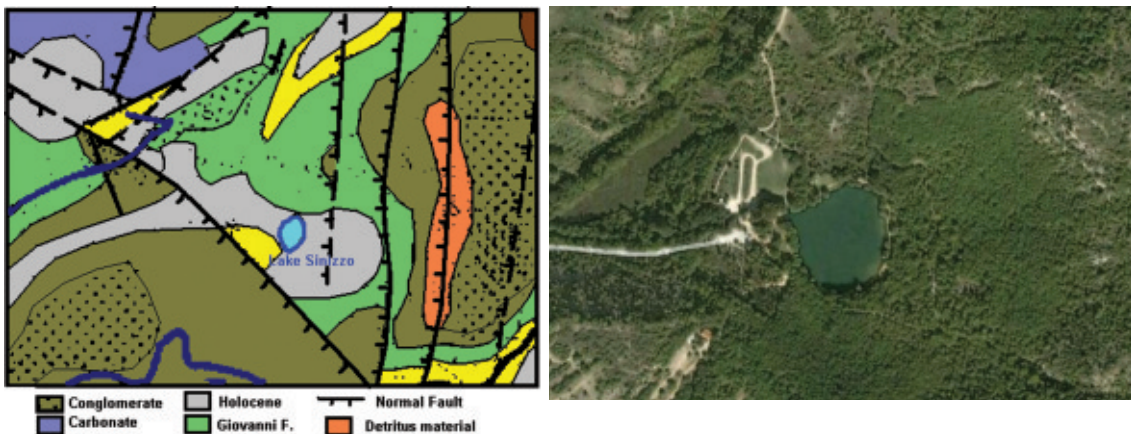
The Abruzzi region is karstic and many sinkholes and dolines exist in the epicentral area. The Sinizzo lake is a doline lake with embankment reinforcement on its northwest side (Figure 18). The lake is 9.8m deep and it has an average diameter of 122.7m (Bertini *et al.* 1989). Extensive ground failures took place around the shore (Figure 19). Although the surrounding ground is mainly calcareous conglomerate, the lake bed is composed of Holocene deposits.

Figure 18. Geology and satellite image of Sinizzo lake and its close vicinity.

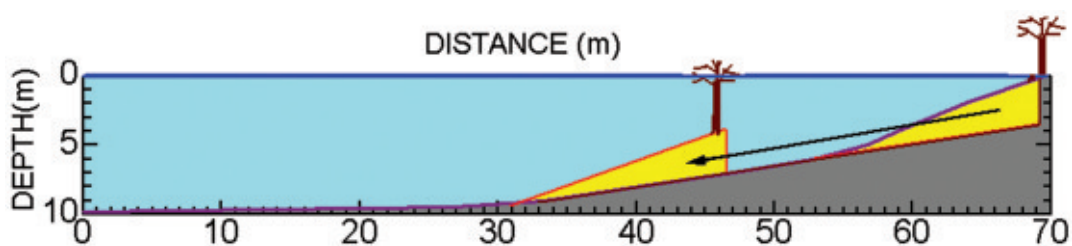
Figure 20 shows the movement of the failed ground mass in space, while Figure 21 depicts the time-history of displacement response of the mass center, Shear strength properties of the sliding surface, unit weight of ground and saturation condition are also given in Figure 21. Although further experimental studies are needed to obtain the physical and mechanical properties of the sliding surface, the estimations seem to be quite reasonable in view of properties of similar ground.

Figure 20. Lakebed profile and inferred movement of the failed body of ground.

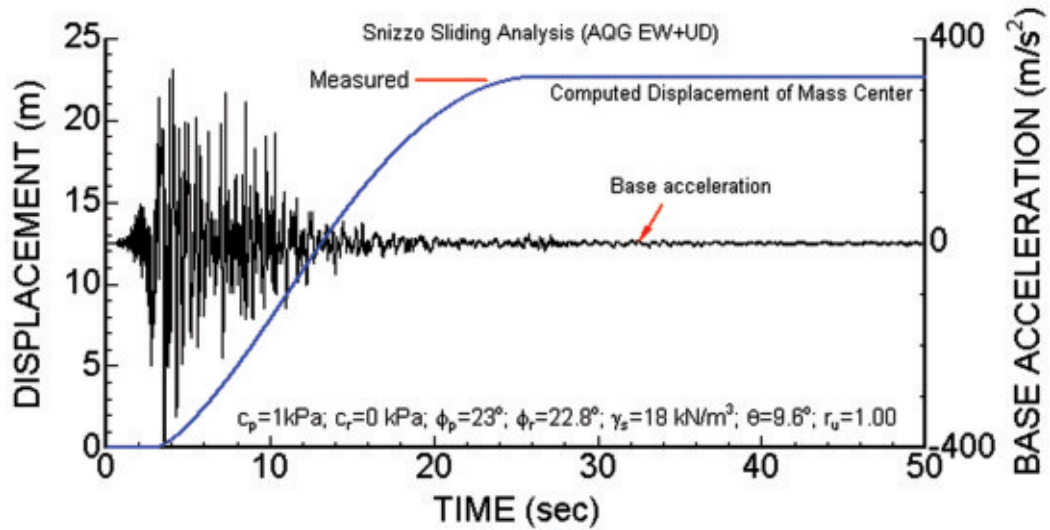
Figure 21. Time history of displacement of mass center of the failed body of ground.

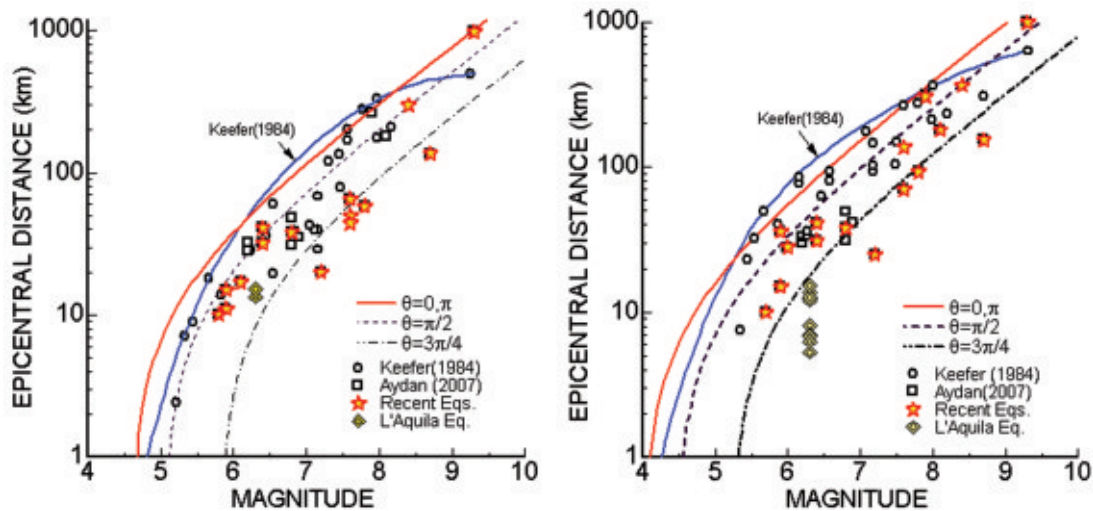
ous case histories as shown in Figure 24. It is noted that the observations made during L'Aquila earthquake are generally in accordance with empirical bounds and other previous case history data.

Figure 24. Comparison of data of L'Aquila earthquake with empirical bounds.

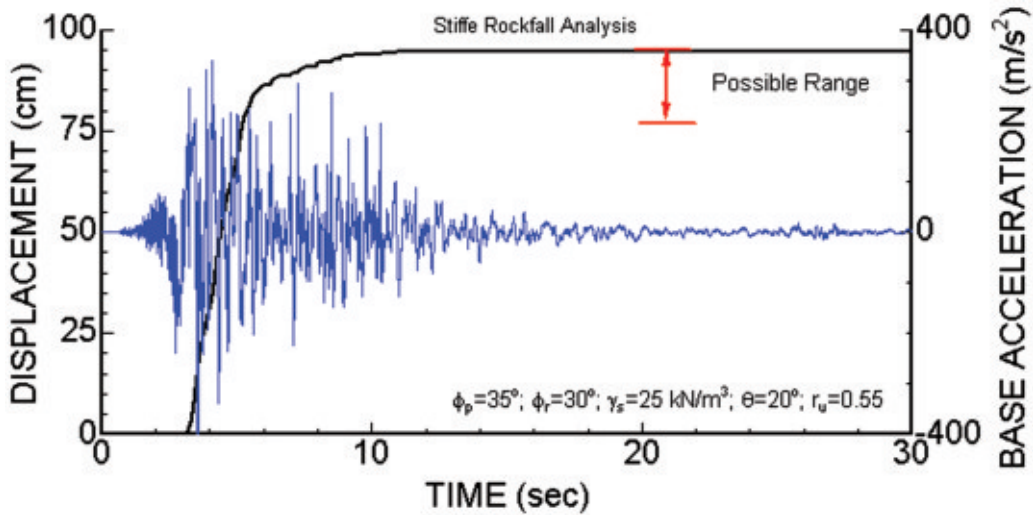
inclination of the block is taken as 20° in view of the limestone bedding inclination in the vicinity of Stiffe. Figure 26 shows the computational results for the record taken at the AQQ station under half saturated conditions, as there is no acceleration record in the vicinity of Stiffe. The static and kinetic friction angles of the interface between the base and block was taken as 35° and 30° in view of experimental results available to the authors for the bedding planes of Alpine limestone. Although it is essential to perform rock mechanics tests on the interface characteristics of the fallen rock block, the chosen values should be sufficient for this preliminary analysis. For the chosen values of interface properties, the computed relative displacement is 94.7 cm. If the shortest side of the block is selected, the block would definitely start to fall. If the other side is chosen, it would be at a limiting state. As the measured size of the block is approximate, the computed results should be sufficient to explain why the rock block fall occurred. A

Figure 26. Computational results for the initiation of rock fall at Stiffe.

toppling mode failure was not possible as the applied acceleration was less than 0.43 g.

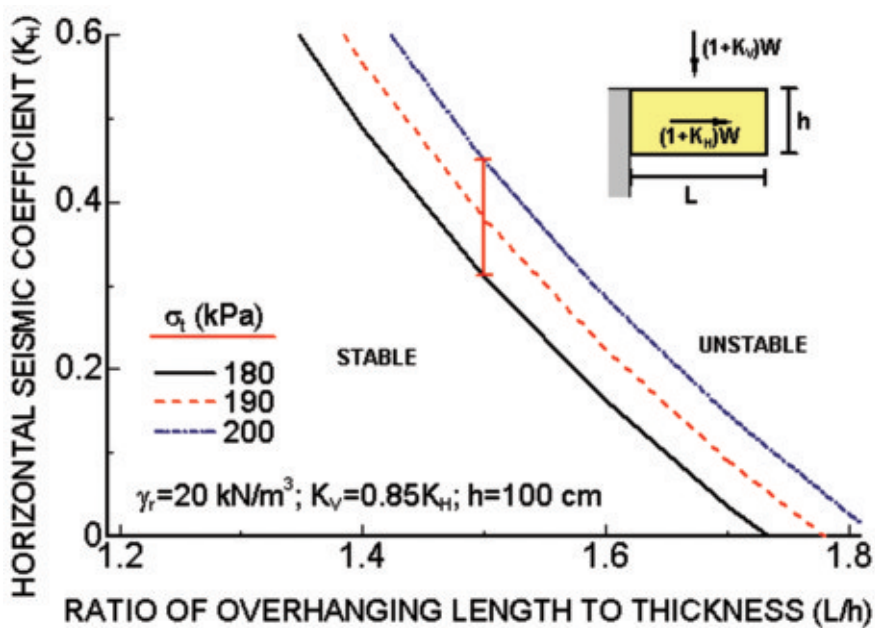
As shown in Figure 25(a), overhanging slopes of conglomeratic deposits were fallen at San Demetrio ne' Vestini. The surfaces of the fallen blocks imply that they have failed in tension. The dynamic stability of these fallen overhanging slopes may be analysed by considering a flexural toppling mode (Aydan and Kawamoto 1987, 1992). The overhanging length of the fallen blocks due to flexural toppling failure was about 150 to 170 cm, while their thickness about 100 cm. Figure 27 shows the computational results for a tensile strength ranging between 180 and 200 kPa while the unit weight

of rock was assumed to be 20 kN/m³. Furthermore, the ratio of vertical to horizontal acceleration was assumed to be 0.85, with the consideration of measured maximum acceleration values. The matrix of conglomerate is calcareous and it is relatively weak. The estimation of the tensile strength of conglomerate at this site seems to be quite acceptable. In the same site, there are many overhanging conglomerate layers. The length of stable overhanging conglomerate layers observed is generally less than 100–120 cm. These observations are in accordance with the computational results.

Figure 27. Computational results for failed overhanging slopes at San Demetrio.

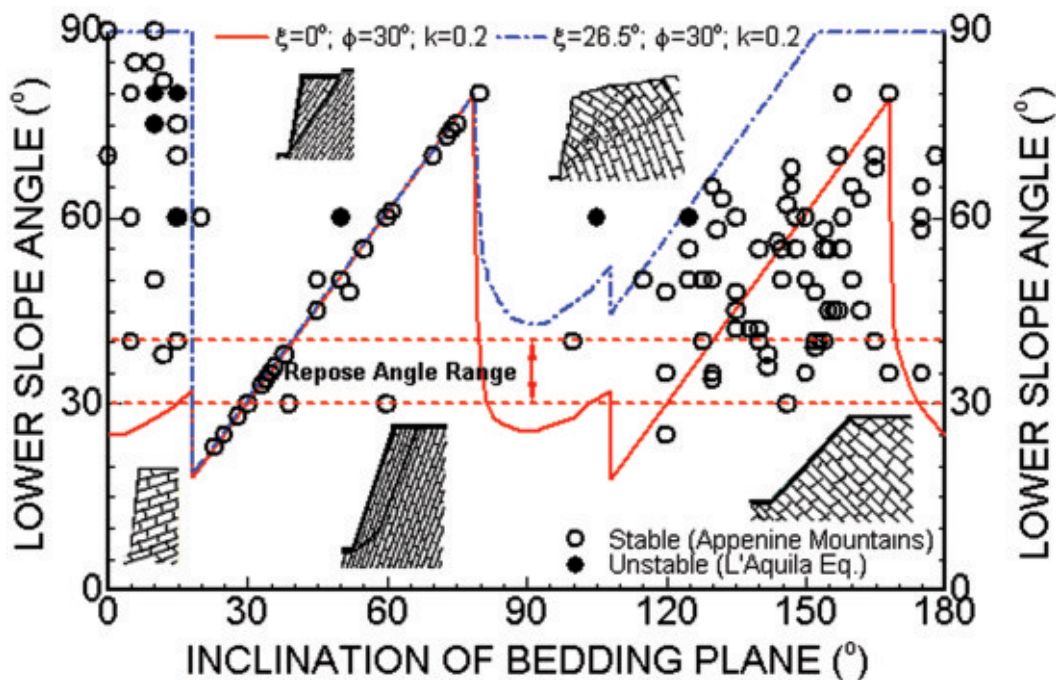
light of the methods of Aydan and his colleagues (Aydan *et al.*, 1989; Aydan and Kawamoto, 1992; Kumsar *et al.* 2000; Aydan and Kumsar, 2009). Figure 28 compares results with observational data from stable and unstable slopes. The data compiled by the first author from natural rock slopes of Apennines are also plotted.

Apennines are composed of limestone and other calcareous rocks of different geologic age. As a result, their stability is influenced by the orientation of the bedding planes as well as normal faults. During the compilation of data, it was noted that, when layers are thin, the slope angle for stability under natural conditions is drastically reduced. Furthermore, when layers dip into the slope, the naturally stable slope angle tends to be almost equal to that of the bedding plane. For layers dipping into the mountainside, the stable slope angle is almost equal to or greater than that of the normal to the bedding planes. When it is greater than the angle of normal, its value ranges from 5° to 35°. When the slope becomes higher, the stable slope angle tends to converge to that of the normal to the bedding plane. The angle of repose of a slope debris ranges between 30° and 40°. Figure 28 was prepared as a guideline for local engineers to select the slope-cutting angles to be adopted in actual restoration of the failed slopes.

Figure 28. Comparison of observational data with computational results from previous studies (ξ : intermittency angle; k : horizontal seismic coefficient; ϕ : friction angle).

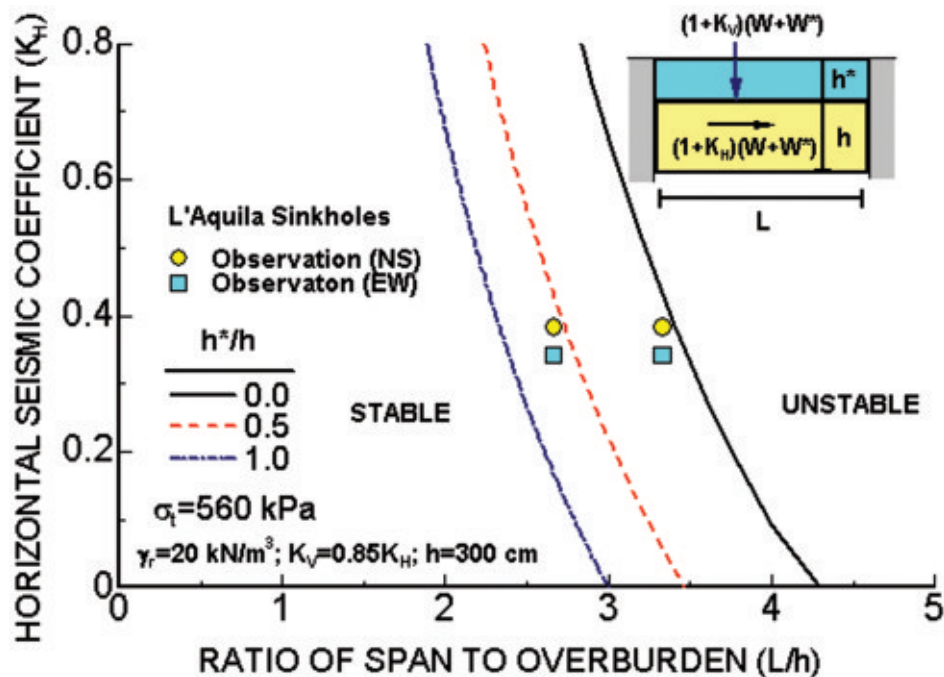
Figure 30. Comparison of computational results with observational results.

strength of the roof material were assumed to be 20 kN/m³ and 560 kPa, respectively. The site observations indicated that a 300 cm deep trench was excavated on one side of the sinkhole site. Therefore, the trench excavations for sewage pipes drastically reduced the effective roof thickness. As expected, the increase of surcharge load drastically reduces the seismic resistance of roof of karstic caves.

The ratio of the longest dimension of sinkholes to roof thickness is plotted in the same Figure 30 using the maximum EW and NS horizontal acceleration values. The case histories fall in the unstable domain computed with the mathematical model using the material properties and measured geometries of sinkholes. The tensile strength of the in-situ rock mass is remarkably similar to the observations made on Ryukyu limestone caves and cliffs in Japan (Tokashiki and Aydan, 2008). From these computational and observational results it may be concluded that the deep sewage trench excavation and high ground acceleration played a major role in causing the instability of karstic caves resulting in sinkholes in

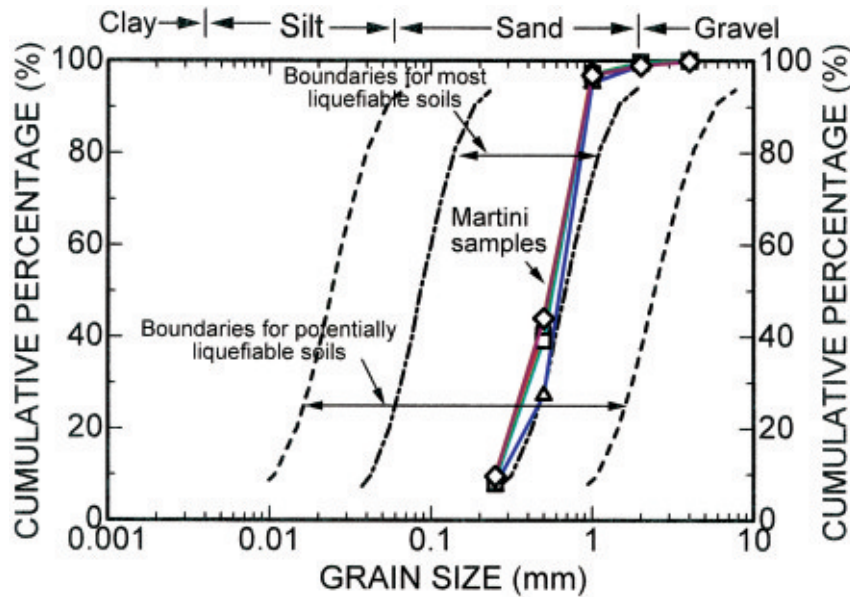
Figure 32. Grain size distribution and comparison of liquefaction bounds.

tion of sand boils, respectively. Boiled sand is almost homogenous and its grain size distribution falls within the easily-liquefiable bounds according to Japan Port and Harbour Research Institute classification (1997).

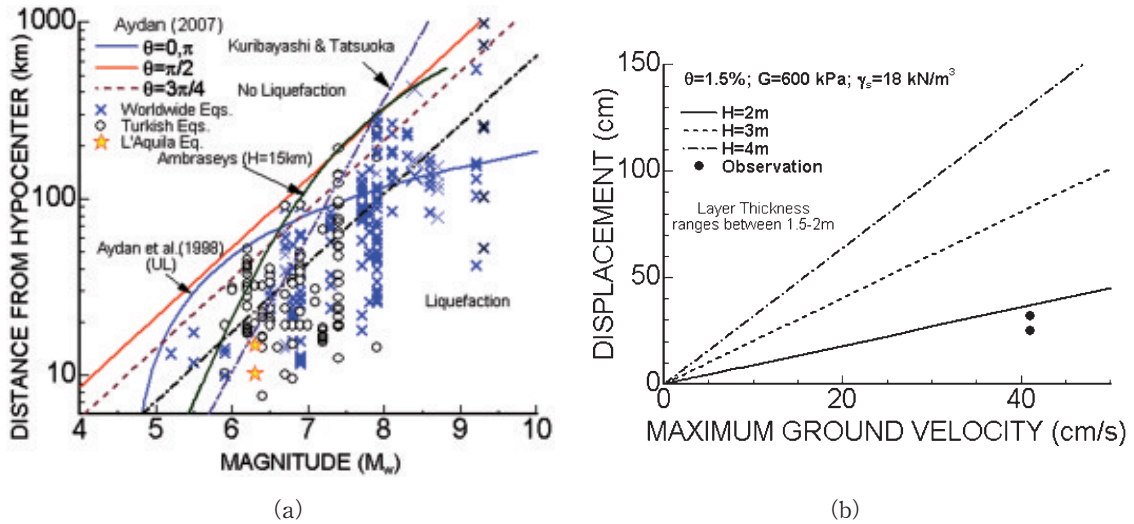
Figure 33(a) compares the empirical bounds proposed by several researchers for the limit of ground liquefaction with observations. The observations are within the limits of liquefiable ground. Since the number of data is at present quite limited, new data may give more accurate results.

Figure 33. Comparison of observations with estimations from the method proposed by Aydan *et al.* (2008) based on maximum ground velocity.

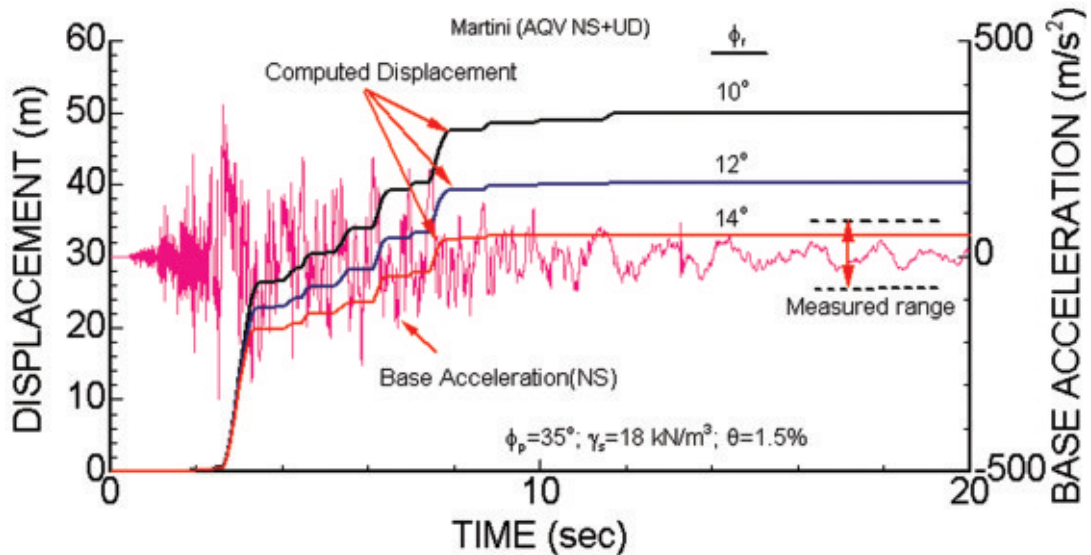
Additional comparative evaluations are based on the use of ground motion data in close vicinity of the liquefaction site of Martini district. Figure 34 compares the estimations with the observation. In the computation, the NS and UD ground motion records of AQK station were used. The residual friction angle ranged between 10 and 14 degrees while keeping the peak friction angle 35 degrees. The observation is close to the computation for 14 degrees residual friction. These evaluations are preliminary and further experimental and computational studies are needed.

Figure 34. Comparison of observations with estimations from the method proposed by Aydan *et al.* (2008) based on rigid body model.
